# Access Compliance Report

## Public Rights-of-Way

### (Curb Ramps)

| Intersection ID: 46373 | Main Street: HONOR_GUARD_AV | Cross Street: ROYAL_CASTLE_CT | Location: SW |

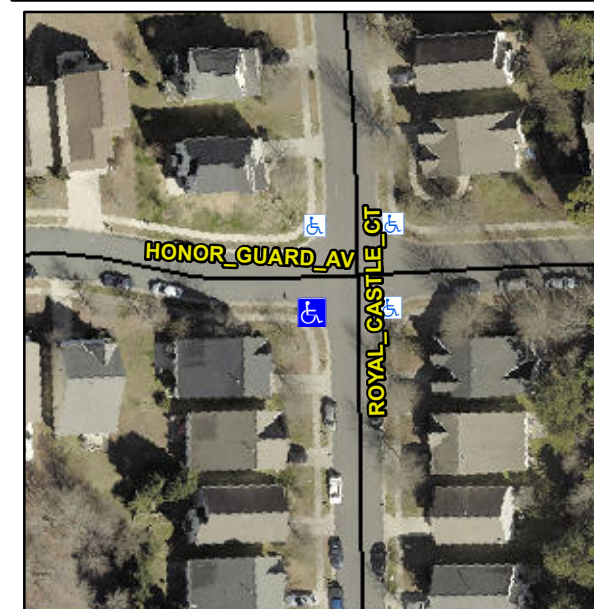
| ADA ID: 7B0F4DD062D3 | Ramp Type: PerpDiag | Initial Pass/Fail: Fail | Overall Compliance: No |
| Severity Score: 22.5 | | | |

**Not Found, R304.5.1, R304.2.2, R304.5.3**

| Compliance | Description | Data | Compliance | Description | Data |
|---|---|---|---|---|---|
| N/A | Ramp Length (in) | 42.0 | No | Ramp Slope (%) | 10.1 |
| No | Ramp Width (in) | 43.0 | No | Ramp XSlope (%) | 2.5 |

**Remove & Replace Curb Ramp With Two New Directional Ramps or Equivalent.**
