Access Compliance Report

Public Rights-of-Way

(Curb Ramps)

Intersection ID: 15123	Main Street: EASTWAY_DR_RA	Cross Street: EASTWAY_DR	Location: SE
ADA ID: 7B26A65356C6	Ramp Type: Perp	Initial Pass/Fail: Fail	Overall Compliance: No
Severity Score: 61.25			
Codes/Mitigation Info/Possible Solution		Field Measurements/Component Compliance

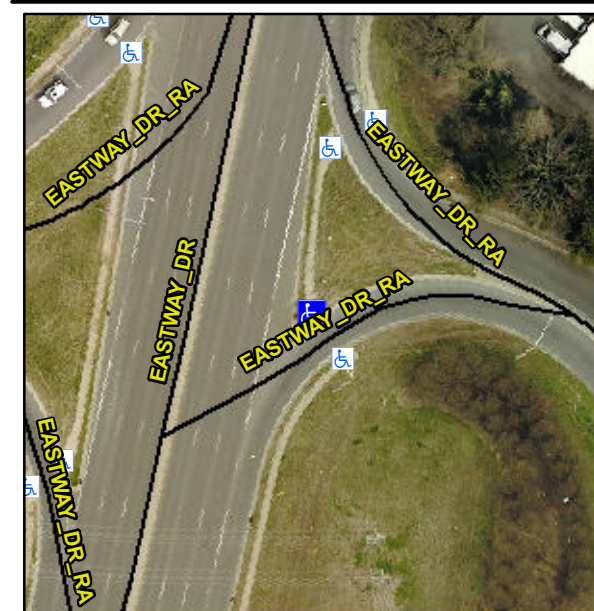
Compliance	Description	Data	Compliance	Description	Data
N/A	Ramp Length (in)	86.5	No	Ramp Slope (%)	16.2
No	Ramp Width (in)	31.5	Yes	Ramp XSlope (%)	4.0
N/A	Flare Type LT	N/A	N/A	Flare Type RT	N/A
N/A	Flare Slope LT (%)	N/A	N/A	Flare Slope RT (%)	N/A
N/A	Flare Traversable LT?	N/A	N/A	Flare Traversable RT?	N/A
N/A	Landing Length (in)	N/A	N/A	DWS Provided?	N/A
N/A	Landing Width (in)	N/A	N/A	DWS Contrast?	N/A
N/A	Landing Slope (%)	N/A	N/A	DWS Length (in)	N/A
N/A	Landing X Slope (%)	N/A	N/A	DWS Full Width?	N/A
N/A	Landing Curb? (Y/N)	N/A	N/A	DWS Offset (in)	N/A
N/A	Shared Landing?	N/A			
N/A	Gutter Ponding?	N/A	N/A	Gutter Slope (%)	N/A
N/A	Gutter Lip Ht (in)	N/A	N/A	Gutter X Slope (%)	N/A
N/A	Painted X Walk1?	No	N/A	Painted X Walk2?	N/A
	X Walk 1 Direction	To S		X Walk 2 Direction	N/A
N/A	X Walk 1 Width (in)	N/A	N/A	X Walk 2 Width (in)	N/A
	X Walk 1 Slope (%)	4.9		X Walk 2 Slope (%)	N/A
	X Walk 1 X Slope (%)	4.7		X Walk 2 X Slope (%)	N/A

N/A	Ramp inside XWalk1?	N/A	N/A	Ramp inside XWalk2?	N/A
	Road Slope (%)	N/A	N/A	Clear Space?	N/A
	Road X Slope (%)	N/A	N/A	Clear Space to XWalk (in)	N/A
N/A	Any Obstructions?	N/A	N/A	Storm Grate/Utility Hazard?	N/A
	Obstruction Type			Storm Grate/Utility Type	
		N/A			N/A
			Yes	Surface Condition? (G/P)	Good

Possible Solutions:

Remove & Replace Entire Ramp.

R304.5.1, R304.2.2
