Access Compliance Report

Public Rights-of-Way

(Curb Ramps)

Intersection ID: 13889	Main Street: DENVIEW_LN	Cross Street: KENHILL_DR	Location: NW
ADA ID: 7B35912047FA	Ramp Type: Directional1	Initial Pass/Fail: Fail	Overall Compliance: No
Severity Score: 1.25			
Codes/Mitigation Info/Possible Solution		Field Measurements/Component Compliance

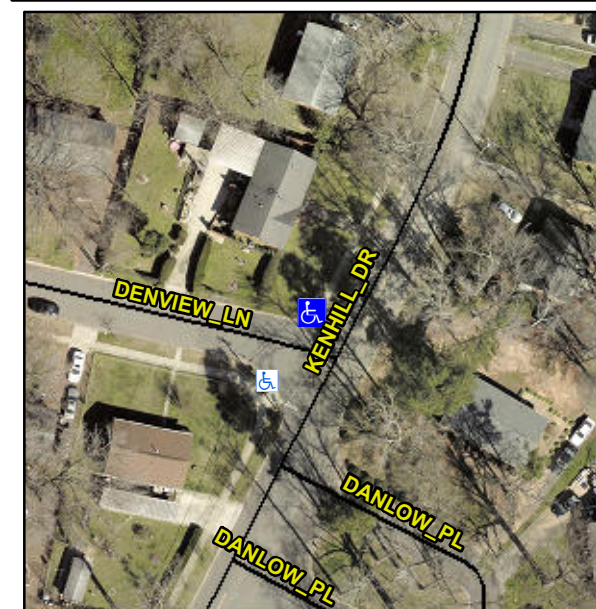
Compliance	Description	Data	Compliance	Description	Data
N/A	Ramp Length (in)	63.0	N/A	Grade Break?	N/A
Yes	Ramp Width (in)	48.0	N/A	Grade Break Slope (%)	0.0
Yes	Ramp Slope (%)	5.3	N/A	Grade Break XSlope (%)	0.0
No	Ramp XSlope (%)	2.2			
N/A	Flare Type LT	N/A	N/A	Flare Type RT	N/A
N/A	Flare Slope LT (%)	N/A	N/A	Flare Slope RT (%)	0.0
N/A	Flare Traversable LT?	N/A	N/A	Flare Traversable RT?	N/A
N/A	Landing Length (in)	0.0	N/A	DWS Provided?	N/A
N/A	Landing Width (in)	0.0	N/A	DWS Contrast?	N/A
N/A	Landing Slope (%)	0.0	N/A	DWS Length (in)	N/A
N/A	Landing X Slope (%)	0.0	N/A	DWS Full Width?	N/A
N/A	Landing Curb? (Y/N)	N/A	N/A	DWS Offset LT (in)	N/A
N/A	Shared Landing?	N/A	N/A	DWS Offset RT (in)	N/A
N/A	Gutter Ponding?	0.0	N/A	Gutter Slope (%)	N/A
N/A	Gutter Lip Ht (in)	0.0	N/A	Gutter X Slope (%)	N/A
N/A	Painted X Walk1?	No		Road Slope (%)	4.7
	X Walk 1 Direction	To S		Road X Slope (%)	1.1
	X Walk 1 Width (in)	N/A		Clear Space?	N/A

X Walk 1 Slope (%)	4.7	N/A	Clear Space to XWalk (in)	N/A
	X Walk 1 X Slope (%)	1.1	N/A	Storm Grate/Utility Hazard?	N/A
N/A	Ramp inside XWalk1?	N/A		Storm Grate/Utility Type	
N/A	Any Obstructions?	N/A			N/A
	Obstruction Type		Yes	Surface Condition? (G/P)	Good
			N/A	Curb Slope (%)	21.1

Remove & Replace Entire Ramp.

R304.5.3

\$ 1600.00
