Intersection ID: 53418	Main Street: ARDREY_KELL_RD	Cross Street: SOUTHGROVE_ST	Location:	NW
ADA ID: 7B4CB20B6BE8	Ramp Type: PerpDiag	Initial Pass/Fail: Fail	Overall Compliance: No	Severity Score: 13.75

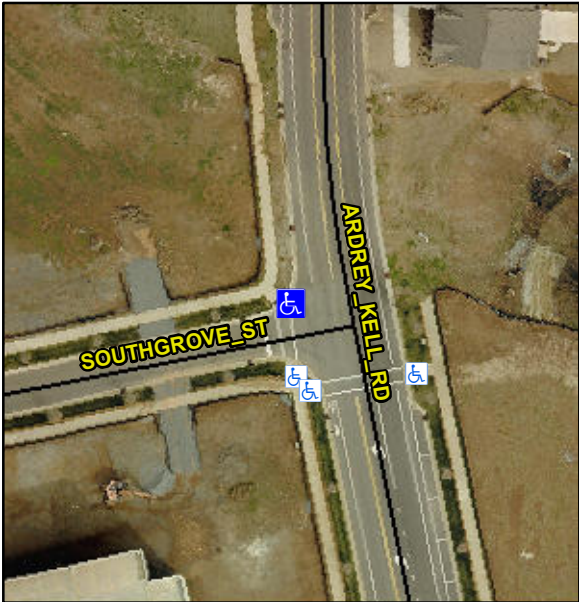
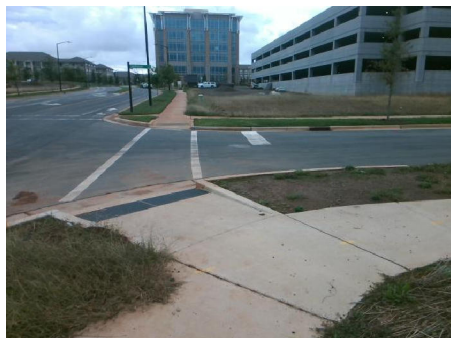
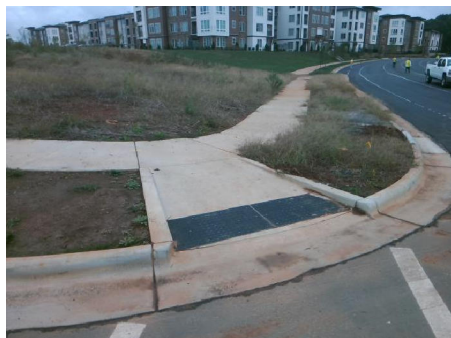
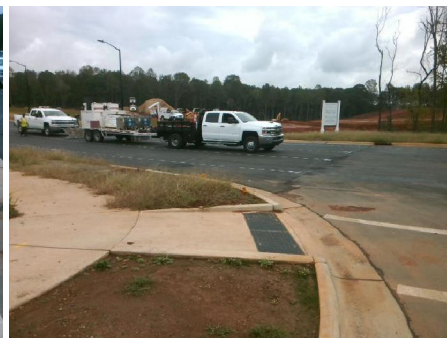
Possible Solutions:							
	<b>Remove &amp; Replace Curb Ramp With Two New Directional Ramps or Equivalent.</b>							
	Surveyor Notes:							
	<b>N/A</b>							
	PROW/ADA:							
	<b>Not Found, R304.2.2, R304.5.3</b>							
Street 1 Name	SOUTHGROVE ST		Compliance	Description	Data	Compliance	Description	Data
Stop Condition-Street 2	None		N/A	Ramp Length (in)	94.0	No	Ramp Slope (%)	9.1
Street 2 Name	ARDREY KELL RD		Yes	Ramp Width (in)	61.0	No	Ramp XSlope (%)	2.6
Stop Condition-Street 1	None		N/A	Flare Type LT	N/A	N/A	Flare Type RT	N/A
			N/A	Flare Slope LT (%)	N/A	N/A	Flare Slope RT (%)	N/A
			N/A	Flare Traversable LT?	N/A	N/A	Flare Traversable RT?	N/A
			N/A	Landing Length (in)	N/A	N/A	DWS Provided?	N/A
			N/A	Landing Width (in)	N/A	N/A	DWS Contrast?	N/A
			N/A	Landing Slope (%)	N/A	N/A	DWS Length (in)	N/A
			N/A	Landing X Slope (%)	N/A	N/A	DWS Full Width?	N/A

N/A	Landing Curb? (Y/N)	N/A	N/A	DWS Offset (in)	N/A
			N/A	Shared Landing?	N/A			
			N/A	Gutter Ponding?	N/A	N/A	Gutter Slope (%)	N/A
			N/A	Gutter Lip Ht (in)	N/A	N/A	Gutter X Slope (%)	N/A
			N/A	Painted X Walk1?	Yes	N/A	Painted X Walk2?	No
				X Walk 1 Direction	To S		X Walk 2 Direction	To E
			N/A	X Walk 1 Width (in)	70.0	N/A	X Walk 2 Width (in)	N/A
				X Walk 1 Slope (%)	3.7		X Walk 2 Slope (%)	1.3
				X Walk 1 X Slope (%)	1.2		X Walk 2 X Slope (%)	1.9
			N/A	Ramp inside XWalk1?	Yes	N/A	Ramp inside XWalk2?	N/A
				Road Slope (%)	0.5	N/A	Clear Space?	N/A
				Road X Slope (%)	2.0	N/A	Clear Space to XWalk (in)	N/A
			N/A	Any Obstructions?	N/A	N/A	Storm Grate/Utility Hazard?	N/A
				Obstruction Type			Storm Grate/Utility Type	
Total Cost:	\$ 3200.00				N/A			N/A
						Yes	Surface Condition? (G/P)	Good
