Access Compliance Report Public Rights-of-Way (Curb Ramps)

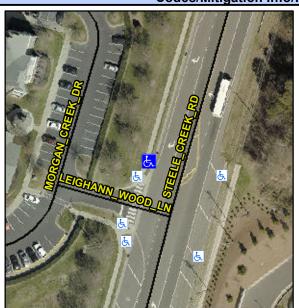
Intersection ID: 50566 Main Street: LEIGHANN_WOOD_LN Cross Street: STEELE_CREEK_RD Location: NW **Severity Score:** ADA ID: 7B4F00961C0C Ramp Type: Perp Initial Pass/Fail: Fail **Overall Compliance: No** 25

Field Measurements/Component Compliance								
Compliance Description		Data	Compl	liance	Description	Data		
N/A	Ramp Length (in)	48.0	No	Ramp	Slope (%)	13.9		
Yes	Ramp Width (in)	48.0	Yes	Ramp	XSlope (%)	0.4		
N/A	Flare Type LT	N/A	N/A	Flare	Type RT	N/A		
N/A	Flare Slope LT (%)	N/A	N/A	Flare	Slope RT (%)	N/A		
N/A	Flare Traversable LT?	N/A	N/A	Flare	Traversable RT?	N/A		
N/A	Landing Length (in)	N/A	N/A	DWS	Provided?	N/A		
N/A	Landing Width (in)	N/A	N/A	DWS	Contrast?	N/A		
N/A	Landing Slope (%)	N/A	N/A	DWS	Length (in)	N/A		
N/A	Landing X Slope (%)	N/A	N/A	DWS	Full Width?	N/A		
N/A	Landing Curb? (Y/N)	N/A	N/A	DWS	Offset (in)	N/A		
N/A	Shared Landing?	N/A						
N/A	Gutter Ponding?	N/A	N/A	Gutte	r Slope (%)	N/A		
N/A	Gutter Lip Ht (in)	N/A	N/A	Gutte	r X Slope (%)	N/A		
N/A	Painted X Walk1?	No	N/A	Painte	ed X Walk2?	N/A		
	X Walk 1 Direction	To SE		X Wa	k 2 Direction	N/A		
N/A	X Walk 1 Width (in)	N/A	N/A	X Wa	k 2 Width (in)	N/A

X Walk 1 Slope (%)	2.8		X Wa	k 2 Slope (%)	N/A		
	X Walk 1 X Slope (%)	0.8		X Wa	k 2 X Slope (%)	N/A		
N/A	Ramp inside XWalk1?	N/A	N/A	Ramp	inside XWalk2?	N/A		
	Road Slope (%)	N/A	N/A	Clear	Space?	N/A		
	Road X Slope (%)	N/A	N/A	Clear	Space to XWalk (in)	N/A		
N/A	Any Obstructions?	N/A	N/A	Storm	Grate/Utility Hazard?	N/A		
	Obstruction Type			Storm	Grate/Utility Type			
		N/A				N/A		
			Yes	Surfa	ce Condition? (G/P)	Good

•	
F	Possible Solutions:
	Remove & Replace Entire Ramp.
ė	
9	Surveyor Notes:
	N/A
	PROW/ADA:
ľ	
	Not Found, R304.2.2
g	
_
