Access Compliance Report

Public Rights-of-Way

(Curb Ramps)

Intersection ID: 30508	Main Street: PLANTERS_ESTATES_DR	Cross Street: SUNRISE_VIEW_DR	Location: SE
ADA ID: 7B5C4275647B	Ramp Type: PerpDiag	Initial Pass/Fail: Fail	Overall Compliance: No
Severity Score: 22.5			
Codes/Mitigation Info/Possible Solution		Field Measurements/Component Compliance

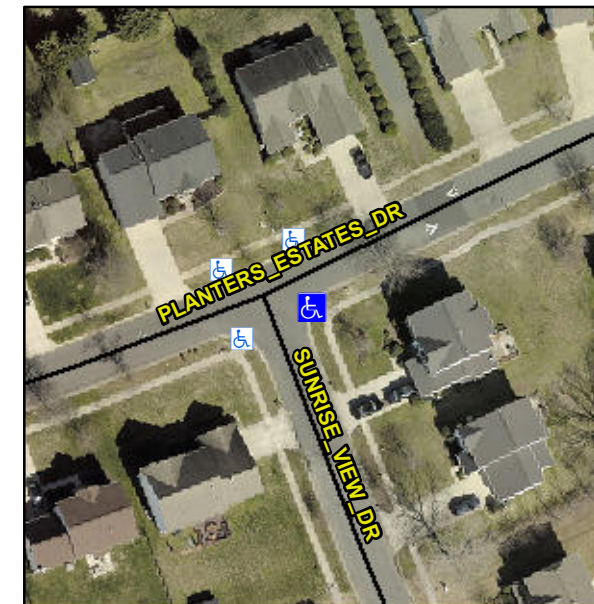
Compliance	Description	Data	Compliance	Description	Data
N/A	Ramp Length (in)	44.0	No	Ramp Slope (%)	10.3
No	Ramp Width (in)	47.5	No	Ramp XSlope (%)	2.4
N/A	Flare Type LT	N/A	N/A	Flare Type RT	N/A
N/A	Flare Slope LT (%)	N/A	N/A	Flare Slope RT (%)	N/A
N/A	Flare Traversable LT?	N/A	N/A	Flare Traversable RT?	N/A
N/A	Landing Length (in)	N/A	N/A	DWS Provided?	N/A
N/A	Landing Width (in)	N/A	N/A	DWS Contrast?	N/A
N/A	Landing Slope (%)	N/A	N/A	DWS Length (in)	N/A
N/A	Landing X Slope (%)	N/A	N/A	DWS Full Width?	N/A
N/A	Landing Curb? (Y/N)	N/A	N/A	DWS Offset (in)	N/A
N/A	Shared Landing?	N/A			
N/A	Gutter Ponding?	N/A	N/A	Gutter Slope (%)	N/A
N/A	Gutter Lip Ht (in)	N/A	N/A	Gutter X Slope (%)	N/A
N/A	Painted X Walk1?	No	N/A	Painted X Walk2?	No
	X Walk 1 Direction	To NW		X Walk 2 Direction	To SW
N/A	X Walk 1 Width (in)	N/A	N/A	X Walk 2 Width (in)	N/A
	X Walk 1 Slope (%)	4.7		X Walk 2 Slope (%)	2.3
	X Walk 1 X Slope (%)	0.5		X Walk 2 X Slope (%)	3.6

N/A	Ramp inside XWalk1?	N/A	N/A	Ramp inside XWalk2?	N/A
	Road Slope (%)	0.1	N/A	Clear Space?	N/A
	Road X Slope (%)	4.3	N/A	Clear Space to XWalk (in)	N/A
N/A	Any Obstructions?	N/A	N/A	Storm Grate/Utility Hazard?	N/A
	Obstruction Type			Storm Grate/Utility Type	
		N/A			N/A
			Yes	Surface Condition? (G/P)	Good

Possible Solutions:

Remove & Replace Curb Ramp With Two New Directional Ramps or Equivalent.
