# Access Compliance Report

## Public Rights-of-Way

### (Curb Ramps)

Intersection ID: 18784	Main Street: SEACROFT_RD	Cross Street: SENECA_PL	Location: SW
ADA ID: 7B5CC8687F66	Ramp Type: PerpDiag	Initial Pass/Fail: Fail	Overall Compliance: No
			Severity Score: 21.25

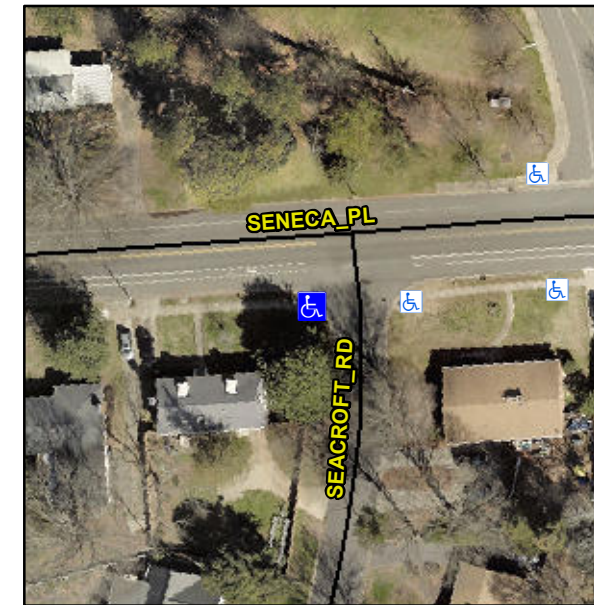
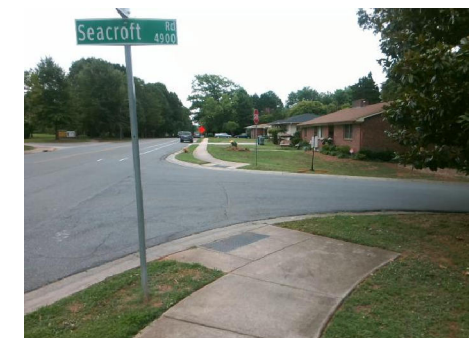
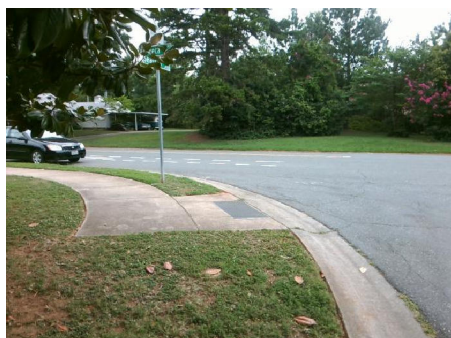
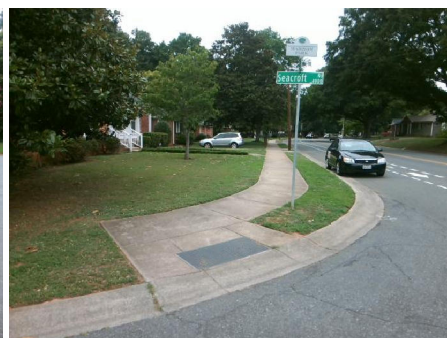
**Not Found, R304.5.1, R304.5.3**

Compliance	Description	Data	Compliance	Description	Data
N/A	Ramp Length (in)	50.0	Yes	Ramp Slope (%)	6.3
No	Ramp Width (in)	42.0	No	Ramp XSlope (%)	5.8
N/A	Flare Type LT	N/A	N/A	Flare Type RT	N/A
N/A	Flare Slope LT (%)	N/A	N/A	Flare Slope RT (%)	N/A
N/A	Flare Traversable LT?	N/A	N/A	Flare Traversable RT?	N/A
N/A	Landing Length (in)	N/A	N/A	DWS Provided?	N/A
N/A	Landing Width (in)	N/A	N/A	DWS Contrast?	N/A
N/A	Landing Slope (%)	N/A	N/A	DWS Length (in)	N/A
N/A	Landing X Slope (%)	N/A	N/A	DWS Full Width?	N/A
N/A	Landing Curb? (Y/N)	N/A	N/A	DWS Offset (in)	N/A
N/A	Shared Landing?	N/A			
N/A	Gutter Ponding?	N/A	N/A	Gutter Slope (%)	N/A
N/A	Gutter Lip Ht (in)	N/A	N/A	Gutter X Slope (%)	N/A
N/A	Painted X Walk1?	No	N/A	Painted X Walk2?	No
	X Walk 1 Direction	To E		X Walk 2 Direction	To N
N/A	X Walk 1 Width (in)	N/A	N/A	X Walk 2 Width (in)	N/A
	X Walk 1 Slope (%)	3.4		X Walk 2 Slope (%)	5.5
	X Walk 1 X Slope (%)	4.0		X Walk 2 X Slope (%)	1.4

N/A	Ramp inside XWalk1?	N/A	N/A	Ramp inside XWalk2?	N/A
	Road Slope (%)	1.4	N/A	Clear Space?	N/A
	Road X Slope (%)	5.0	N/A	Clear Space to XWalk (in)	N/A
N/A	Any Obstructions?	N/A	N/A	Storm Grate/Utility Hazard?	N/A
	Obstruction Type			Storm Grate/Utility Type	
		N/A			N/A
			Yes	Surface Condition? (G/P)	Good

**Remove & Replace Curb Ramp With Two New Directional Ramps or Equivalent.**
