Access Compliance Report

Public Rights-of-Way

(Curb Ramps)

Intersection ID: 14871	Main Street: DRIFTWOOD_DR	Cross Street: WINTERFIELD_PL	Location: NE
ADA ID: 7B662CA46D1A	Ramp Type: PerpDiag	Initial Pass/Fail: Fail	Overall Compliance: No
Codes/Mitigation Info/Possible Solution			Severity Score: 10
			Field Measurements/Component Compliance

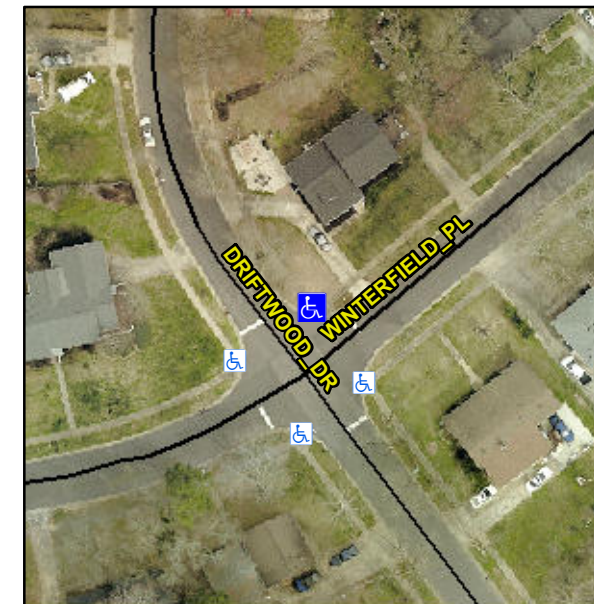
Not Found, R304.5.1, R304.5.3

Compliance	Description	Data	Compliance	Description	Data
N/A	Ramp Length (in)	62.0	Yes	Ramp Slope (%)	5.2
No	Ramp Width (in)	47.5	No	Ramp XSlope (%)	4.7
N/A	Flare Type LT	N/A	N/A	Flare Type RT	N/A
N/A	Flare Slope LT (%)	N/A	N/A	Flare Slope RT (%)	N/A
N/A	Flare Traversable LT?	N/A	N/A	Flare Traversable RT?	N/A
N/A	Landing Length (in)	N/A	N/A	DWS Provided?	N/A
N/A	Landing Width (in)	N/A	N/A	DWS Contrast?	N/A
N/A	Landing Slope (%)	N/A	N/A	DWS Length (in)	N/A
N/A	Landing X Slope (%)	N/A	N/A	DWS Full Width?	N/A
N/A	Landing Curb? (Y/N)	N/A	N/A	DWS Offset (in)	N/A
N/A	Shared Landing?	N/A			
N/A	Gutter Ponding?	N/A	N/A	Gutter Slope (%)	N/A
N/A	Gutter Lip Ht (in)	N/A	N/A	Gutter X Slope (%)	N/A
N/A	Painted X Walk1?	No	N/A	Painted X Walk2?	No
	X Walk 1 Direction	To SW		X Walk 2 Direction	To SE
N/A	X Walk 1 Width (in)	N/A	N/A	X Walk 2 Width (in)	N/A
	X Walk 1 Slope (%)	5.0		X Walk 2 Slope (%)	0.2
	X Walk 1 X Slope (%)	2.0		X Walk 2 X Slope (%)	3.1

N/A	Ramp inside XWalk1?	N/A	N/A	Ramp inside XWalk2?	N/A
	Road Slope (%)	3.7	N/A	Clear Space?	N/A
	Road X Slope (%)	1.7	N/A	Clear Space to XWalk (in)	N/A
N/A	Any Obstructions?	N/A	N/A	Storm Grate/Utility Hazard?	N/A
	Obstruction Type			Storm Grate/Utility Type	
		N/A			N/A
			Yes	Surface Condition? (G/P)	Good

Remove & Replace Curb Ramp With Two New Directional Ramps or Equivalent.
