# Access Compliance Report

## Public Rights-of-Way

### (Curb Ramps)

Intersection ID: 8131	Main Street: ORR_RD	Cross Street: UNIVERSITY_COMMERCIAL_PL	Location: SE
ADA ID: 7B731FC48749	Ramp Type: Perp	Initial Pass/Fail: Fail	Overall Compliance: No
Severity Score: 21.25			
Codes/Mitigation Info/Possible Solution		Field Measurements/Component Compliance

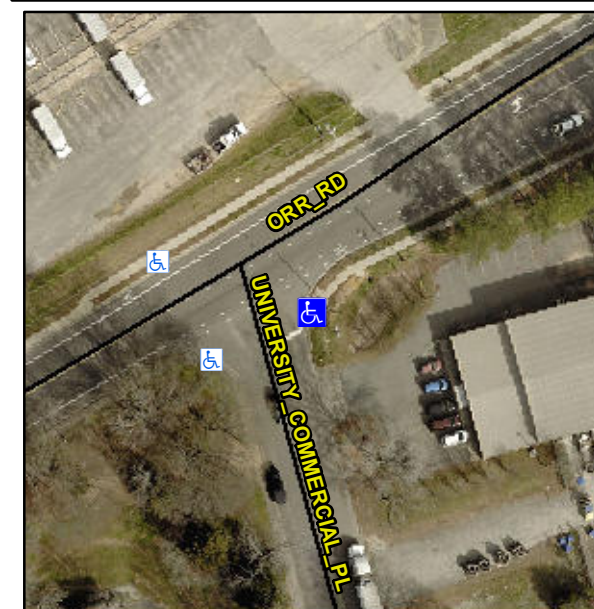
**Not Found, R304.5.1, R304.5.3**

Compliance	Description	Data	Compliance	Description	Data
N/A	Ramp Length (in)	47.0	Yes	Ramp Slope (%)	7.6
No	Ramp Width (in)	47.0	No	Ramp XSlope (%)	5.3
N/A	Flare Type LT	N/A	N/A	Flare Type RT	N/A
N/A	Flare Slope LT (%)	N/A	N/A	Flare Slope RT (%)	N/A
N/A	Flare Traversable LT?	N/A	N/A	Flare Traversable RT?	N/A
N/A	Landing Length (in)	N/A	N/A	DWS Provided?	N/A
N/A	Landing Width (in)	N/A	N/A	DWS Contrast?	N/A
N/A	Landing Slope (%)	N/A	N/A	DWS Length (in)	N/A
N/A	Landing X Slope (%)	N/A	N/A	DWS Full Width?	N/A
N/A	Landing Curb? (Y/N)	N/A	N/A	DWS Offset (in)	N/A
N/A	Shared Landing?	N/A			
N/A	Gutter Ponding?	N/A	N/A	Gutter Slope (%)	N/A
N/A	Gutter Lip Ht (in)	N/A	N/A	Gutter X Slope (%)	N/A
N/A	Painted X Walk1?	No	N/A	Painted X Walk2?	N/A
	X Walk 1 Direction	To W		X Walk 2 Direction	N/A
N/A	X Walk 1 Width (in)	N/A	N/A	X Walk 2 Width (in)	N/A
	X Walk 1 Slope (%)	1.7		X Walk 2 Slope (%)	N/A
	X Walk 1 X Slope (%)	2.3		X Walk 2 X Slope (%)	N/A

N/A	Ramp inside XWalk1?	N/A	N/A	Ramp inside XWalk2?	N/A
	Road Slope (%)	N/A	N/A	Clear Space?	N/A
	Road X Slope (%)	N/A	N/A	Clear Space to XWalk (in)	N/A
N/A	Any Obstructions?	N/A	N/A	Storm Grate/Utility Hazard?	N/A
	Obstruction Type			Storm Grate/Utility Type	
		N/A			N/A
		Yes		Surface Condition? (G/P)	Good

Possible Solutions:

**Remove & Replace Entire Ramp.**

Total Cost: \$ 1850.00
