Access Compliance Report

Public Rights-of-Way (Curb Ramps)

Intersection ID: 14911	Main Street: MATHER_GREEN_AV	Cross Street: OLMSTED_PARK_PL	Location: S
ADA ID: 7B75FE26C92D	Ramp Type: Perp	Initial Pass/Fail: Fail	Overall Compliance: No
Severity Score: 12.5			
Codes/Mitigation Info/Possible Solution		Field Measurements/Component Compliance

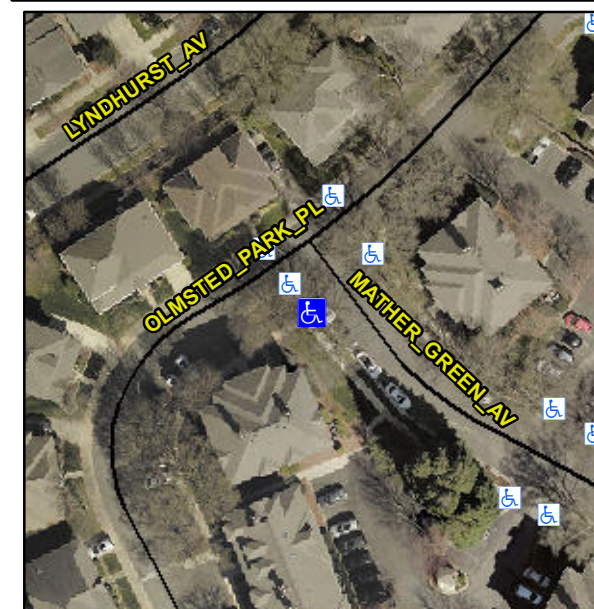
Not Found, R304.2.2

Compliance	Description	Data	Compliance	Description	Data
N/A	Ramp Length (in)	43.0	No	Ramp Slope (%)	11.0
Yes	Ramp Width (in)	48.0	Yes	Ramp XSlope (%)	0.2
N/A	Flare Type LT	N/A	N/A	Flare Type RT	N/A
N/A	Flare Slope LT (%)	N/A	N/A	Flare Slope RT (%)	N/A
N/A	Flare Traversable LT?	N/A	N/A	Flare Traversable RT?	N/A
N/A	Landing Length (in)	N/A	N/A	DWS Provided?	N/A
N/A	Landing Width (in)	N/A	N/A	DWS Contrast?	N/A
N/A	Landing Slope (%)	N/A	N/A	DWS Length (in)	N/A
N/A	Landing X Slope (%)	N/A	N/A	DWS Full Width?	N/A
N/A	Landing Curb? (Y/N)	N/A	N/A	DWS Offset (in)	N/A
N/A	Shared Landing?	N/A			
N/A	Gutter Ponding?	N/A	N/A	Gutter Slope (%)	N/A
N/A	Gutter Lip Ht (in)	N/A	N/A	Gutter X Slope (%)	N/A
N/A	Painted X Walk1?	No	N/A	Painted X Walk2?	N/A
	X Walk 1 Direction	To NE		X Walk 2 Direction	N/A
N/A	X Walk 1 Width (in)	N/A	N/A	X Walk 2 Width (in)	N/A
	X Walk 1 Slope (%)	1.4		X Walk 2 Slope (%)	N/A
	X Walk 1 X Slope (%)	1.8		X Walk 2 X Slope (%)	N/A

N/A	Ramp inside XWalk1?	N/A	N/A	Ramp inside XWalk2?	N/A
	Road Slope (%)	N/A	N/A	Clear Space?	N/A
	Road X Slope (%)	N/A	N/A	Clear Space to XWalk (in)	N/A
N/A	Any Obstructions?	N/A	N/A	Storm Grate/Utility Hazard?	N/A
	Obstruction Type			Storm Grate/Utility Type	
		N/A			N/A
			Yes	Surface Condition? (G/P)	Good

Remove & Replace Entire Ramp.

Total Cost: \$ 1850.00
