# Access Compliance Report

## Public Rights-of-Way

### (Curb Ramps)

Intersection ID: 3539	Main Street: HARRIS_CORNERS_PY	Cross Street: MAPLE_VIEW_LN	Location: NE
ADA ID: 7B8EB7EB06F4	Ramp Type: Perp	Initial Pass/Fail: Fail	Overall Compliance: No
			Severity Score: 21.25

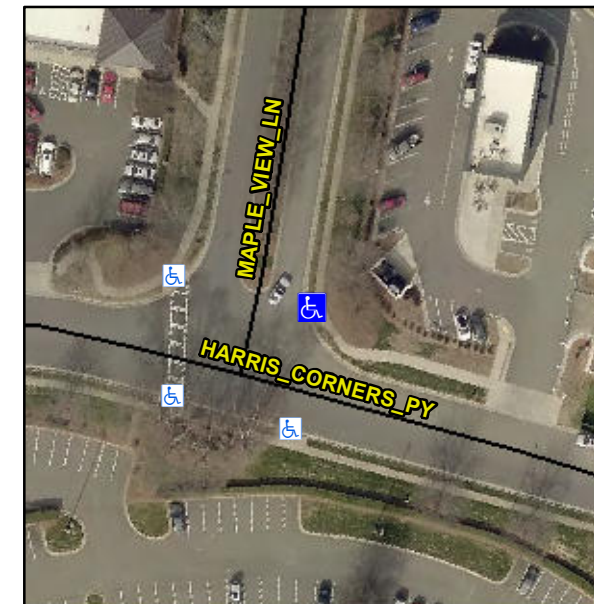
Compliance	Description	Data	Compliance	Description	Data
N/A	Ramp Length (in)	40.0	No	Ramp Slope (%)	11.9
No	Ramp Width (in)	47.0	Yes	Ramp XSlope (%)	0.1
N/A	Flare Type LT	N/A	N/A	Flare Type RT	N/A
N/A	Flare Slope LT (%)	N/A	N/A	Flare Slope RT (%)	N/A
N/A	Flare Traversable LT?	N/A	N/A	Flare Traversable RT?	N/A
N/A	Landing Length (in)	N/A	N/A	DWS Provided?	N/A
N/A	Landing Width (in)	N/A	N/A	DWS Contrast?	N/A
N/A	Landing Slope (%)	N/A	N/A	DWS Length (in)	N/A
N/A	Landing X Slope (%)	N/A	N/A	DWS Full Width?	N/A
N/A	Landing Curb? (Y/N)	N/A	N/A	DWS Offset (in)	N/A
N/A	Shared Landing?	N/A			
N/A	Gutter Ponding?	N/A	N/A	Gutter Slope (%)	N/A
N/A	Gutter Lip Ht (in)	N/A	N/A	Gutter X Slope (%)	N/A
N/A	Painted X Walk1?	No	N/A	Painted X Walk2?	N/A
	X Walk 1 Direction	To NW		X Walk 2 Direction	N/A
N/A	X Walk 1 Width (in)	N/A	N/A	X Walk 2 Width (in)	N/A
	X Walk 1 Slope (%)	7.4		X Walk 2 Slope (%)	N/A
	X Walk 1 X Slope (%)	0.2		X Walk 2 X Slope (%)	N/A

N/A	Ramp inside XWalk1?	N/A	N/A	Ramp inside XWalk2?	N/A
	Road Slope (%)	N/A	N/A	Clear Space?	N/A
	Road X Slope (%)	N/A	N/A	Clear Space to XWalk (in)	N/A
N/A	Any Obstructions?	N/A	N/A	Storm Grate/Utility Hazard?	N/A
	Obstruction Type			Storm Grate/Utility Type	
		N/A			N/A
			Yes	Surface Condition? (G/P)	Good

**Remove & Replace Entire Ramp.**

**R304.5.1, R304.2.2**

Total Cost: \$ 1850.00
