# Access Compliance Report

## Public Rights-of-Way

### (Curb Ramps)

Intersection ID: 24685	Main Street: CARDAMON_CT	Cross Street: WILD_HEATHER_CT	Location: S
ADA ID: 7B8F88A03895	Ramp Type: PerpDiag	Initial Pass/Fail: Fail	Overall Compliance: No
Severity Score: 22.5			
Codes/Mitigation Info/Possible Solution		Field Measurements/Component Compliance

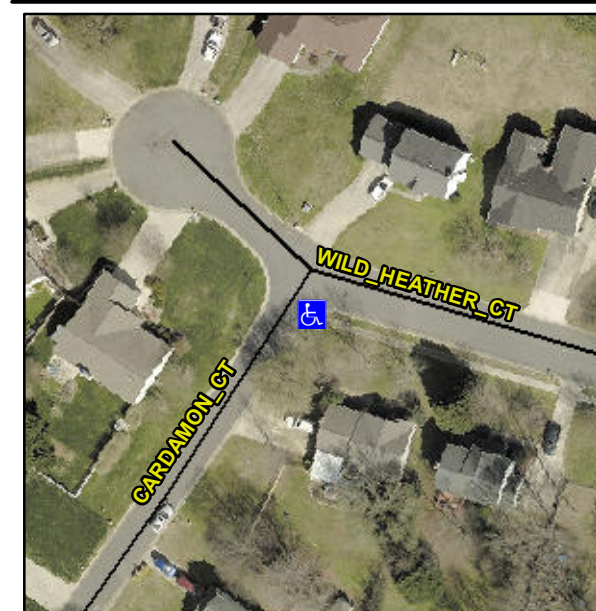
**R304.5.1, R304.2.2, R304.5.3**

Compliance	Description	Data	Compliance	Description	Data
N/A	Ramp Length (in)	93.0	No	Ramp Slope (%)	9.0
No	Ramp Width (in)	44.0	No	Ramp XSlope (%)	4.6
N/A	Flare Type LT	N/A	N/A	Flare Type RT	N/A
N/A	Flare Slope LT (%)	N/A	N/A	Flare Slope RT (%)	N/A
N/A	Flare Traversable LT?	N/A	N/A	Flare Traversable RT?	N/A
N/A	Landing Length (in)	N/A	N/A	DWS Provided?	N/A
N/A	Landing Width (in)	N/A	N/A	DWS Contrast?	N/A
N/A	Landing Slope (%)	N/A	N/A	DWS Length (in)	N/A
N/A	Landing X Slope (%)	N/A	N/A	DWS Full Width?	N/A
N/A	Landing Curb? (Y/N)	N/A	N/A	DWS Offset (in)	N/A
N/A	Shared Landing?	N/A			
N/A	Gutter Ponding?	N/A	N/A	Gutter Slope (%)	N/A
N/A	Gutter Lip Ht (in)	N/A	N/A	Gutter X Slope (%)	N/A
N/A	Painted X Walk1?	No	N/A	Painted X Walk2?	No
	X Walk 1 Direction	To NE		X Walk 2 Direction	To NW
N/A	X Walk 1 Width (in)	N/A	N/A	X Walk 2 Width (in)	N/A
	X Walk 1 Slope (%)	4.5		X Walk 2 Slope (%)	0.1
	X Walk 1 X Slope (%)	1.0		X Walk 2 X Slope (%)	2.8

N/A	Ramp inside XWalk1?	N/A	N/A	Ramp inside XWalk2?	N/A
	Road Slope (%)	1.8	N/A	Clear Space?	N/A
	Road X Slope (%)	3.5	N/A	Clear Space to XWalk (in)	N/A
N/A	Any Obstructions?	N/A	N/A	Storm Grate/Utility Hazard?	N/A
	Obstruction Type			Storm Grate/Utility Type	
		N/A			N/A
			Yes	Surface Condition? (G/P)	Good

Possible Solutions:

**Remove & Replace Curb Ramp With Two New Directional Ramps or Equivalent.**

Total Cost: \$ 3200.00
