## Access Compliance Report Public Rights-of-Way (Curb Ramps)

· · · ·											
Intersection ID: 23277	Main Str	Main Street: S_TRYON_ST			Street:	JOHN_PRICE_RD	Location:	NW			
ADA ID: 7B934BA47A55	Ramp Ty	Ramp Type: Perp			Pass/Fa	ail: Pass Overa	o Severity Score:	25.25			
Codes/Mitigation Info/Possible Solution					Field Measurements/Component Compliance						
		Possible Solutions:			Compliance Description			Data Compliance Description			
S STAN	JOINT LA	Remove & Replace Entire Grind Gutter Lip.	re Ramr	).	N/A	Ramp Length (in)	87.0	Yes	Ramp Slope (%)	7.9

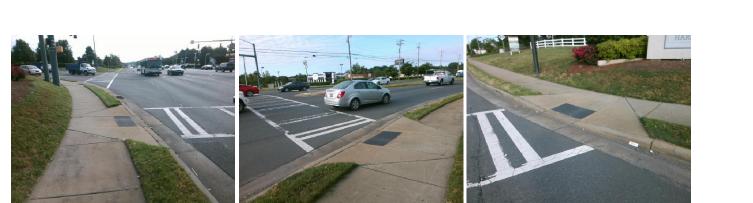
•		Yes	Ramp Width (in)	48.0	No	Ramp XSlope (%)	3.3	
					N/A	Flare Type LT	Sloped	N/A	Flare Type RT	N/A	
	BU A				N/A	Flare Slope LT (%)	7.6	Yes	Flare Slope RT (%)	5.9	
AND AND					N/A	Flare Traversable LT?	Yes	N/A	Flare Traversable RT?	Yes	
A CONTRACTOR					No	Landing Length (in)	N/A	Yes	DWS Provided?	Yes	
		Surveyor Notes:			No	Landing Width (in)	N/A	Yes	DWS Contrast?	Yes	
the second se	A.	N/A			No	Landing Slope (%)	N/A	Yes	DWS Length (in)	24.0	
A A A A A A A A A A A A A A A A A A A					No	Landing X Slope (%)	N/A	Yes	DWS Full Width?	Yes	
All and a second	ALL C				N/A	Landing Curb? (Y/N)	No	No	DWS Offset (in)	4.5	
Test of		<b>&gt;</b>			N/A	Shared Landing?	No				
11/1000		PROW/ADA:			Yes	Gutter Ponding?	No	Yes	Gutter Slope (%)	4.6	
	San V	R304.5.3, R304.2.1, R304	rp.	No	Gutter Lip Ht (in)	1.0	Yes	Gutter X Slope (%)	1.4		
	R304.3.2-Para, R305.2, F	• *	N/A	Painted X Walk1?	Yes	N/A	Painted X Walk2?	N/A

X Walk 1 Direction	To SE		X Walk 2 Direction	N/A		
	116 29				N/A	X Walk 1 Width (in)	115.0	N/A	X Walk 2 Width (in)	N/A	
Street 1 Name	S TRYON ST					X Walk 1 Slope (%)	3.9		X Walk 2 Slope (%)	N/A	
Stop Condition-Street 2	Signal					X Walk 1 X Slope (%)	0.2		X Walk 2 X Slope (%)	N/A	
Street 2 Name	N/A				Yes	Ramp inside XWalk1?	Yes	N/A	Ramp inside XWalk2?	N/A	
Stop Condition-Street 1	N/A					Road Slope (%)	N/A	N/A	Clear Space?	Yes	
						Road X Slope (%)	N/A	N/A	Clear Space to XWalk (in)	N/A	
					Yes	Any Obstructions?	No	Yes	Storm Grate/Utility Hazard?	No	
		Total Cost:	\$	2050.00		Obstruction Type			Storm Grate/Utility Type		
							N/A			N/A

Yes Surface Condition? (G/P) Good
