# Access Compliance Report

## Public Rights-of-Way

### (Curb Ramps)

Intersection ID: 46913	Main Street: PONDEROSA_PINE_LN	Cross Street: PINYON_PINE_LN	Location:	W
ADA ID: 7B9B67151CB9	Ramp Type: PerpDiag	Initial Pass/Fail: Fail	Overall Compliance: No	Severity Score: 25
Codes/Mitigation Info/Possible Solution		Field Measurements/Component Compliance

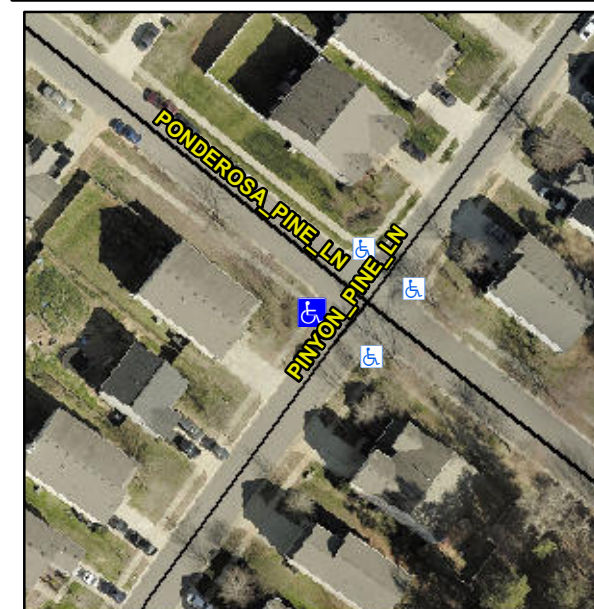
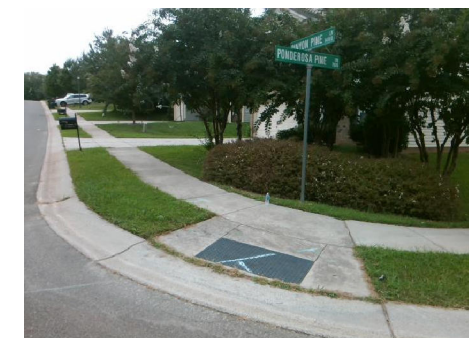
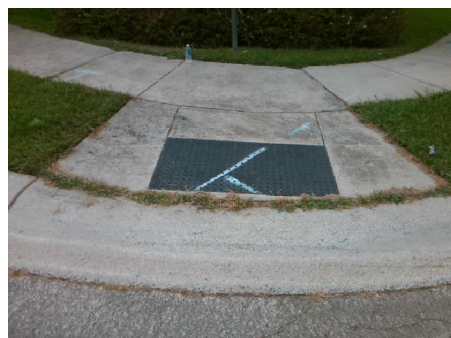
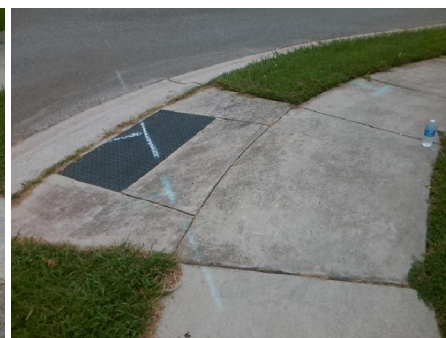
Compliance	Description	Data	Compliance	Description	Data
N/A	Ramp Length (in)	48.5	Yes	Ramp Slope (%)	5.8
Yes	Ramp Width (in)	48.0	No	Ramp XSlope (%)	8.4
N/A	Flare Type LT	N/A	N/A	Flare Type RT	N/A
N/A	Flare Slope LT (%)	N/A	N/A	Flare Slope RT (%)	N/A
N/A	Flare Traversable LT?	N/A	N/A	Flare Traversable RT?	N/A
N/A	Landing Length (in)	N/A	N/A	DWS Provided?	N/A
N/A	Landing Width (in)	N/A	N/A	DWS Contrast?	N/A
N/A	Landing Slope (%)	N/A	N/A	DWS Length (in)	N/A
N/A	Landing X Slope (%)	N/A	N/A	DWS Full Width?	N/A
N/A	Landing Curb? (Y/N)	N/A	N/A	DWS Offset (in)	N/A
N/A	Shared Landing?	N/A			
N/A	Gutter Ponding?	N/A	N/A	Gutter Slope (%)	N/A
N/A	Gutter Lip Ht (in)	N/A	N/A	Gutter X Slope (%)	N/A
N/A	Painted X Walk1?	No	N/A	Painted X Walk2?	No
	X Walk 1 Direction	To S		X Walk 2 Direction	To N
N/A	X Walk 1 Width (in)	N/A	N/A	X Walk 2 Width (in)	N/A
	X Walk 1 Slope (%)	4.5		X Walk 2 Slope (%)	1.3
	X Walk 1 X Slope (%)	1.4		X Walk 2 X Slope (%)	4.4

N/A	Ramp inside XWalk1?	N/A	N/A	Ramp inside XWalk2?	N/A
	Road Slope (%)	3.8	N/A	Clear Space?	N/A
	Road X Slope (%)	2.5	N/A	Clear Space to XWalk (in)	N/A
N/A	Any Obstructions?	N/A	N/A	Storm Grate/Utility Hazard?	N/A
	Obstruction Type			Storm Grate/Utility Type	
		N/A			N/A
			Yes	Surface Condition? (G/P)	Good

**Remove & Replace Curb Ramp With Two New Directional Ramps or Equivalent.**

**R304.5.3**

Total Cost: \$ 3200.00
