Access Compliance Report

Public Rights-of-Way

(Curb Ramps)

Intersection ID: 45496	Main Street: COTTON_PRESS_RD	Cross Street: COTTON_STAND_RD	Location:	N
ADA ID: 7BA5900BB6BE	Ramp Type: PerpDiag	Initial Pass/Fail: Fail	Overall Compliance: No	Severity Score: 22.5
Codes/Mitigation Info/Possible Solution		Field Measurements/Component Compliance

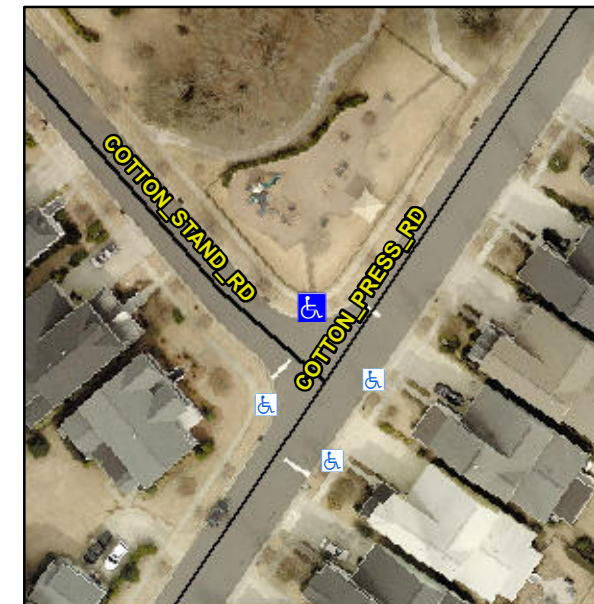
Not Found, R304.5.1, R304.2.2, R304.5.3

Compliance	Description	Data	Compliance	Description	Data
N/A	Ramp Length (in)	73.0	No	Ramp Slope (%)	8.6
No	Ramp Width (in)	36.0	No	Ramp XSlope (%)	2.2
N/A	Flare Type LT	N/A	N/A	Flare Type RT	N/A
N/A	Flare Slope LT (%)	N/A	N/A	Flare Slope RT (%)	N/A
N/A	Flare Traversable LT?	N/A	N/A	Flare Traversable RT?	N/A
N/A	Landing Length (in)	N/A	N/A	DWS Provided?	N/A
N/A	Landing Width (in)	N/A	N/A	DWS Contrast?	N/A
N/A	Landing Slope (%)	N/A	N/A	DWS Length (in)	N/A
N/A	Landing X Slope (%)	N/A	N/A	DWS Full Width?	N/A
N/A	Landing Curb? (Y/N)	N/A	N/A	DWS Offset (in)	N/A
N/A	Shared Landing?	N/A			
N/A	Gutter Ponding?	N/A	N/A	Gutter Slope (%)	N/A
N/A	Gutter Lip Ht (in)	N/A	N/A	Gutter X Slope (%)	N/A
N/A	Painted X Walk1?	No	N/A	Painted X Walk2?	No
	X Walk 1 Direction	To SW		X Walk 2 Direction	To SE
N/A	X Walk 1 Width (in)	N/A	N/A	X Walk 2 Width (in)	N/A
	X Walk 1 Slope (%)	0.9		X Walk 2 Slope (%)	0.0
	X Walk 1 X Slope (%)	2.4		X Walk 2 X Slope (%)	0.7

N/A	Ramp inside XWalk1?	N/A	N/A	Ramp inside XWalk2?	N/A
	Road Slope (%)	1.3	N/A	Clear Space?	N/A
	Road X Slope (%)	0.5	N/A	Clear Space to XWalk (in)	N/A
N/A	Any Obstructions?	N/A	N/A	Storm Grate/Utility Hazard?	N/A
	Obstruction Type			Storm Grate/Utility Type	
		N/A			N/A
			Yes	Surface Condition? (G/P)	Good

Possible Solutions:

Remove & Replace Curb Ramp With Two New Directional Ramps or Equivalent.
