# Access Compliance Report

## Public Rights-of-Way

### (Curb Ramps)

| Intersection ID: 45511 | Main Street: MEADOW_BOTTOM_RD | Cross Street: GINHOUSE_LN | Location: S |

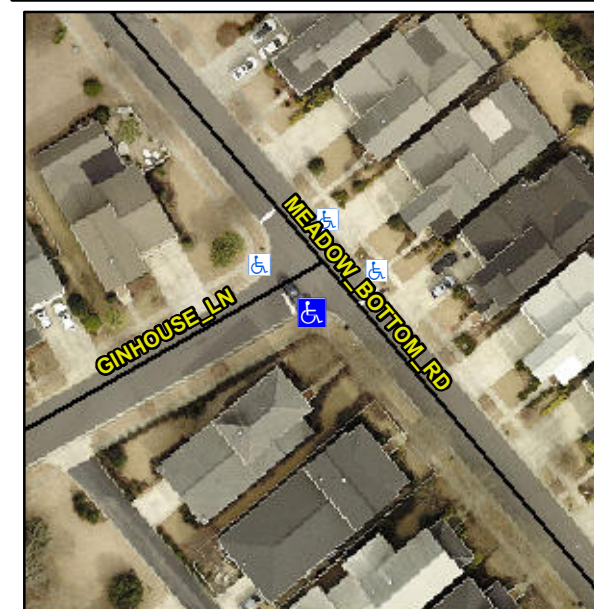
| ADA ID: 7BA93D74F15E | Ramp Type: PerpDiag | Initial Pass/Fail: Fail | Overall Compliance: No |

**Not Found, R304.5.1, R304.2.2, R304.5.3**

| Compliance | Description | Data | Compliance | Description | Data |
|---|---|---|---|---|---|
| N/A | Ramp Length (in) | 70.0 | No | Ramp Slope (%) | 11.1 |
| No | Ramp Width (in) | 31.0 | No | Ramp XSlope (%) | 2.1 |

**Remove & Replace Curb Ramp With Two New Directional Ramps or Equivalent.**

Total Cost: \$ 3200.00
