Access Compliance Report

Public Rights-of-Way

(Curb Ramps)

Intersection ID: N/A	Main Street: TRAILMOOR_RD	Cross Street: BRECKFIELD_CT	Location: W
ADA ID: 7BBE3A8A615A	Ramp Type: PerpDiag	Initial Pass/Fail: Fail	Overall Compliance: No
Codes/Mitigation Info/Possible Solution		Field Measurements/Component Compliance	
Severity Score: 8.75

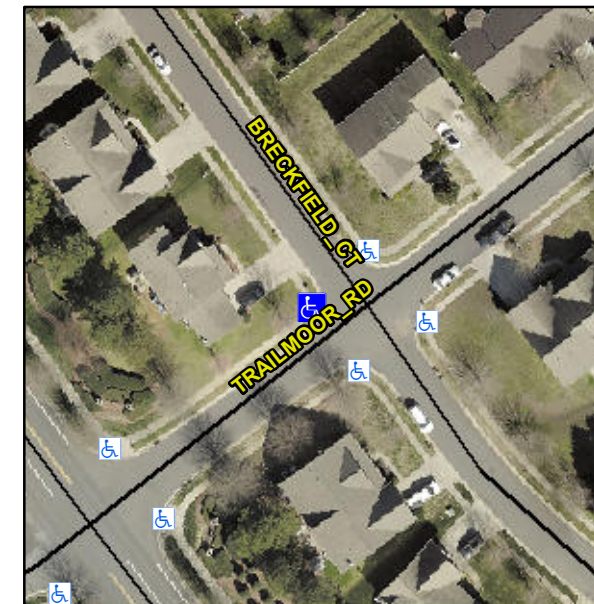
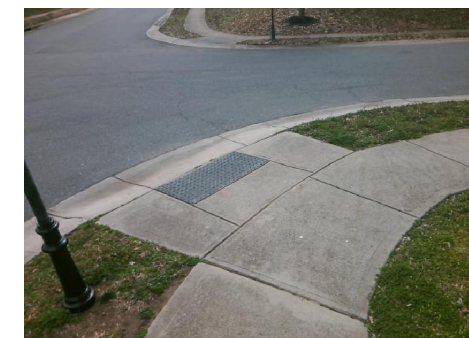
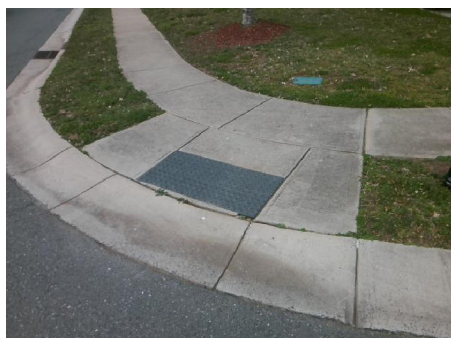
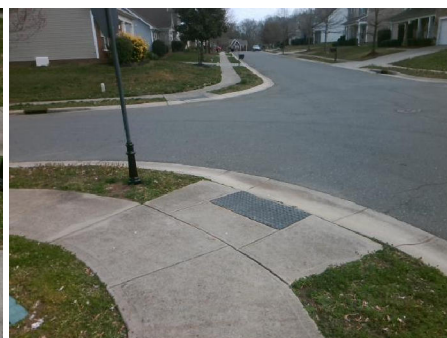
Compliance	Description	Data	Compliance	Description	Data
N/A	Ramp Length (in)	49.0	Yes	Ramp Slope (%)	5.4
No	Ramp Width (in)	42.0	Yes	Ramp XSlope (%)	0.2
N/A	Flare Type LT	N/A	N/A	Flare Type RT	N/A
N/A	Flare Slope LT (%)	N/A	N/A	Flare Slope RT (%)	N/A
N/A	Flare Traversable LT?	N/A	N/A	Flare Traversable RT?	N/A
N/A	Landing Length (in)	N/A	N/A	DWS Provided?	N/A
N/A	Landing Width (in)	N/A	N/A	DWS Contrast?	N/A
N/A	Landing Slope (%)	N/A	N/A	DWS Length (in)	N/A
N/A	Landing X Slope (%)	N/A	N/A	DWS Full Width?	N/A
N/A	Landing Curb? (Y/N)	N/A	N/A	DWS Offset (in)	N/A
N/A	Shared Landing?	N/A			
N/A	Gutter Ponding?	N/A	N/A	Gutter Slope (%)	N/A
N/A	Gutter Lip Ht (in)	N/A	N/A	Gutter X Slope (%)	N/A
N/A	Painted X Walk1?	No	N/A	Painted X Walk2?	No
	X Walk 1 Direction	To SE		X Walk 2 Direction	To NE
N/A	X Walk 1 Width (in)	N/A	N/A	X Walk 2 Width (in)	N/A
	X Walk 1 Slope (%)	1.6		X Walk 2 Slope (%)	4.6
	X Walk 1 X Slope (%)	2.4		X Walk 2 X Slope (%)	2.6

N/A	Ramp inside XWalk1?	N/A	N/A	Ramp inside XWalk2?	N/A
	Road Slope (%)	0.4	N/A	Clear Space?	N/A
	Road X Slope (%)	5.2	N/A	Clear Space to XWalk (in)	N/A
N/A	Any Obstructions?	N/A	N/A	Storm Grate/Utility Hazard?	N/A
	Obstruction Type			Storm Grate/Utility Type	
		N/A			N/A
			Yes	Surface Condition? (G/P)	Good

Remove & Replace Curb Ramp With Two New Directional Ramps or Equivalent.

R304.5.1
