# Access Compliance Report

## Public Rights-of-Way

### (Curb Ramps)

| Intersection ID: N/A | Main Street: BALTUSROL_LN | Cross Street: N/A | Location: W |

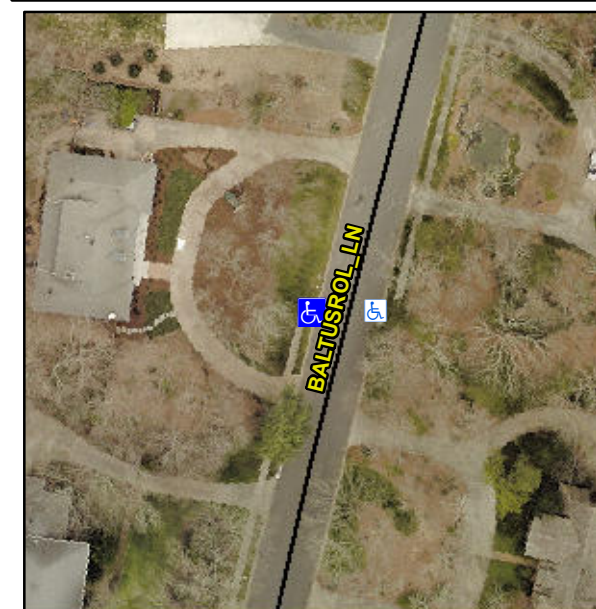
| ADA ID: 7BBEAC65B1DC | Ramp Type: Perp | Initial Pass/Fail: Fail | Overall Compliance: No |
| | | Severity Score: 12.5 | |

**Not Found, R304.5.3**

| Compliance | Description | Data | Compliance | Description | Data |
|---|---|---|---|---|---|
| Yes | Ramp Width (in) | 48.0 | No | Ramp XSlope (%) | 6.4 |

**Remove & Replace Entire Ramp.**

Total Cost: \$ 1850.00
