# Access Compliance Report

## Public Rights-of-Way

### (Curb Ramps)

Intersection ID: 53713	Main Street: N_TRYON_ST	Cross Street: PERIWINKLE_HILL_AV	Location: S
ADA ID: 7BC213331E0A	Ramp Type: Perp	Initial Pass/Fail: Fail	Overall Compliance: No
Severity Score: 21.25			
Codes/Mitigation Info/Possible Solution		Field Measurements/Component Compliance

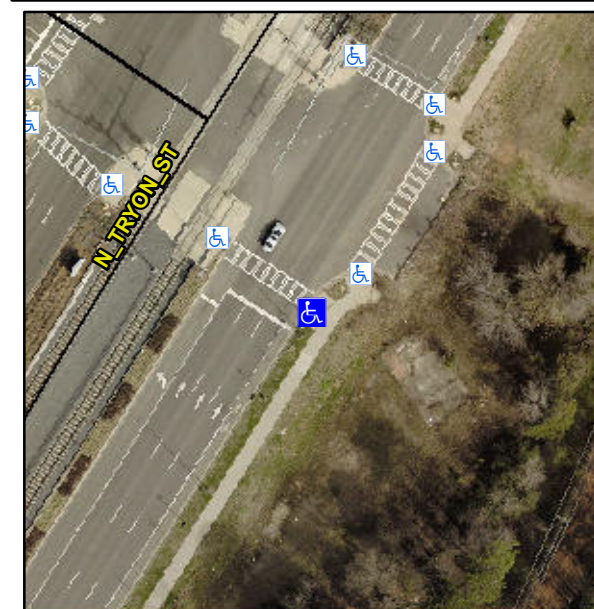
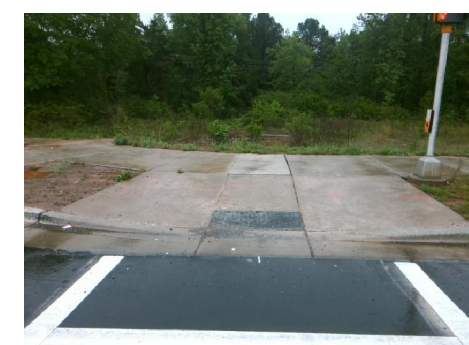
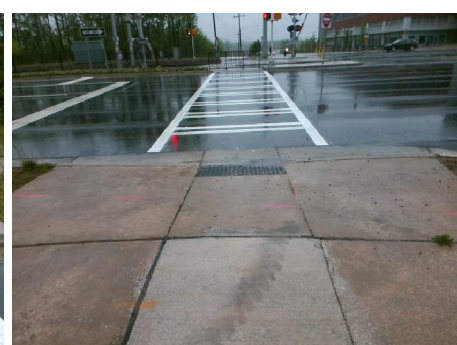
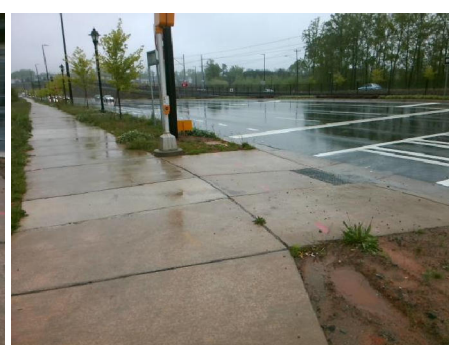
Compliance	Description	Data	Compliance	Description	Data
N/A	Ramp Length (in)	98.0	No	Ramp Slope (%)	8.4
No	Ramp Width (in)	46.5	Yes	Ramp XSlope (%)	1.1
N/A	Flare Type LT	N/A	N/A	Flare Type RT	N/A
N/A	Flare Slope LT (%)	N/A	N/A	Flare Slope RT (%)	N/A
N/A	Flare Traversable LT?	N/A	N/A	Flare Traversable RT?	N/A
N/A	Landing Length (in)	N/A	N/A	DWS Provided?	N/A
N/A	Landing Width (in)	N/A	N/A	DWS Contrast?	N/A
N/A	Landing Slope (%)	N/A	N/A	DWS Length (in)	N/A
N/A	Landing X Slope (%)	N/A	N/A	DWS Full Width?	N/A
N/A	Landing Curb? (Y/N)	N/A	N/A	DWS Offset (in)	N/A
N/A	Shared Landing?	N/A			
N/A	Gutter Ponding?	N/A	N/A	Gutter Slope (%)	N/A
N/A	Gutter Lip Ht (in)	N/A	N/A	Gutter X Slope (%)	N/A
N/A	Painted X Walk1?	Yes	N/A	Painted X Walk2?	N/A
	X Walk 1 Direction	To NW		X Walk 2 Direction	N/A
N/A	X Walk 1 Width (in)	106.0	N/A	X Walk 2 Width (in)	N/A
	X Walk 1 Slope (%)	1.3		X Walk 2 Slope (%)	N/A
	X Walk 1 X Slope (%)	1.1		X Walk 2 X Slope (%)	N/A

N/A	Ramp inside XWalk1?	Yes	N/A	Ramp inside XWalk2?	N/A
	Road Slope (%)	N/A	N/A	Clear Space?	N/A
	Road X Slope (%)	N/A	N/A	Clear Space to XWalk (in)	N/A
N/A	Any Obstructions?	N/A	N/A	Storm Grate/Utility Hazard?	N/A
	Obstruction Type			Storm Grate/Utility Type	
		N/A			N/A
		Yes		Surface Condition? (G/P)	Good

**Remove & Replace Entire Ramp.**

**R304.5.1, R304.2.2**

Total Cost: \$ 1850.00
