Access Compliance Report Public Rights-of-Way (Curb Ramps)

Intersection ID: 43188Main Street: HOVIS_RDCross Street: SALEM_CHURCH_RDLocation:NWADA ID: 7BDB68C60AD6Ramp Type: PerpInitial Pass/Fail: FailOverall Compliance: NoSeverity Score: 21.25

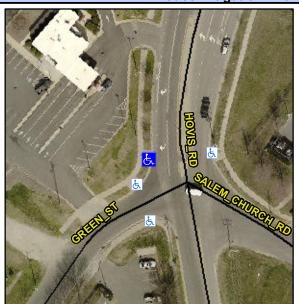
| Possible Solutions: | |
|---|--|
| Not Found, R304.5.1, R304.2.2 | |

| Field Measurements/Component Compliance | | | | | | | |
|---|---|---|---|---|---|---|--|
| N/A | Ramp Length (in) | 97.0 | No | Ramp | Slope (%) | 8.6 | |
| No | Ramp Width (in) | 47.0 | Yes | Ramp | XSlope (%) | 1.5 | |

| Possible Solutions: | |
|---|--|
| Remove & Replace Entire Ramp. | |
