# Access Compliance Report

## Public Rights-of-Way

### (Curb Ramps)

Intersection ID: 46910	Main Street: PENCE_RD	Cross Street: PARKERS_CROSSING_DR	Location: NW
ADA ID: 7BF3D7229FFA	Ramp Type: PerpDiag	Initial Pass/Fail: Fail	Overall Compliance: No
			Severity Score: 21.25

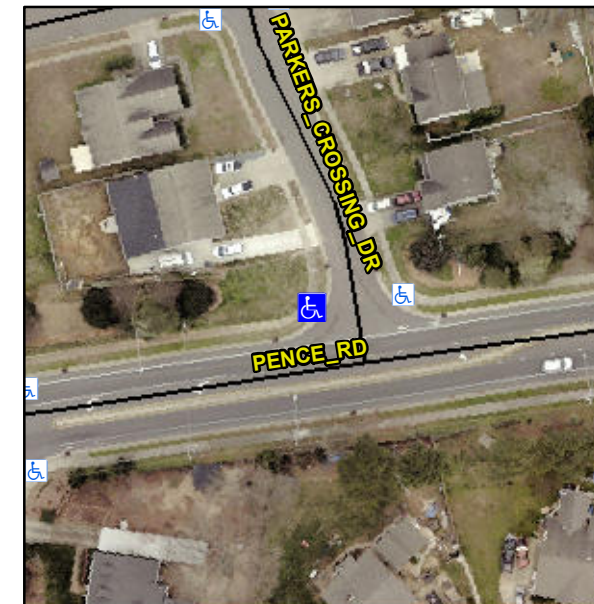
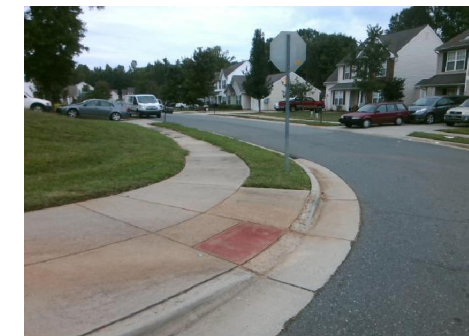
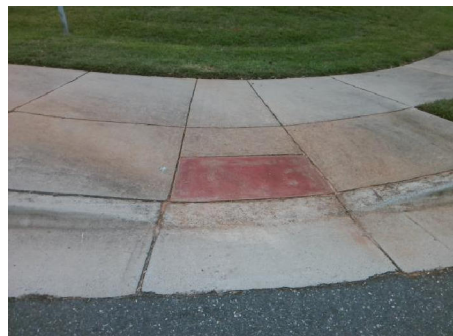
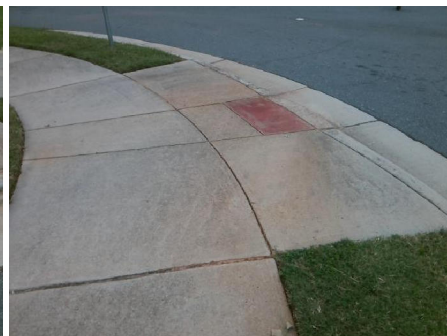
**Not Found, R304.5.1, R304.5.3**

Compliance	Description	Data	Compliance	Description	Data
N/A	Ramp Length (in)	47.0	Yes	Ramp Slope (%)	5.3
No	Ramp Width (in)	37.0	No	Ramp XSlope (%)	5.3
N/A	Flare Type LT	N/A	N/A	Flare Type RT	N/A
N/A	Flare Slope LT (%)	N/A	N/A	Flare Slope RT (%)	N/A
N/A	Flare Traversable LT?	N/A	N/A	Flare Traversable RT?	N/A
N/A	Landing Length (in)	N/A	N/A	DWS Provided?	N/A
N/A	Landing Width (in)	N/A	N/A	DWS Contrast?	N/A
N/A	Landing Slope (%)	N/A	N/A	DWS Length (in)	N/A
N/A	Landing X Slope (%)	N/A	N/A	DWS Full Width?	N/A
N/A	Landing Curb? (Y/N)	N/A	N/A	DWS Offset (in)	N/A
N/A	Shared Landing?	N/A			
N/A	Gutter Ponding?	N/A	N/A	Gutter Slope (%)	N/A
N/A	Gutter Lip Ht (in)	N/A	N/A	Gutter X Slope (%)	N/A
N/A	Painted X Walk1?	No	N/A	Painted X Walk2?	No
	X Walk 1 Direction	To S		X Walk 2 Direction	To E
N/A	X Walk 1 Width (in)	N/A	N/A	X Walk 2 Width (in)	N/A
	X Walk 1 Slope (%)	2.4		X Walk 2 Slope (%)	5.2
	X Walk 1 X Slope (%)	6.4		X Walk 2 X Slope (%)	1.8

N/A	Ramp inside XWalk1?	N/A	N/A	Ramp inside XWalk2?	N/A
	Road Slope (%)	4.8	N/A	Clear Space?	N/A
	Road X Slope (%)	5.2	N/A	Clear Space to XWalk (in)	N/A
N/A	Any Obstructions?	N/A	N/A	Storm Grate/Utility Hazard?	N/A
	Obstruction Type			Storm Grate/Utility Type	
		N/A			N/A
			Yes	Surface Condition? (G/P)	Good

**Remove & Replace Curb Ramp With Two New Directional Ramps or Equivalent.**
