Access Compliance Report

Public Rights-of-Way

(Curb Ramps)

Intersection ID: 11619	Main Street: E_15TH_ST	Cross Street: N_CALDWELL_ST	Location: W
ADA ID: 7C1197036556	Ramp Type: PerpDiag	Initial Pass/Fail: Fail	Overall Compliance: No
		Severity Score: 35

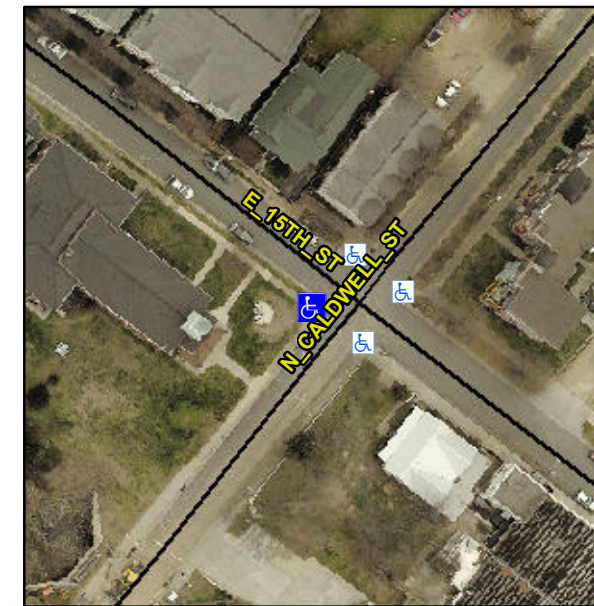
Not Found, R304.5.1

Compliance	Description	Data	Compliance	Description	Data
N/A	Ramp Length (in)	48.0	Yes	Ramp Slope (%)	7.6
No	Ramp Width (in)	30.0	Yes	Ramp XSlope (%)	0.1
N/A	Flare Type LT	N/A	N/A	Flare Type RT	N/A
N/A	Flare Slope LT (%)	N/A	N/A	Flare Slope RT (%)	N/A
N/A	Flare Traversable LT?	N/A	N/A	Flare Traversable RT?	N/A
N/A	Landing Length (in)	N/A	N/A	DWS Provided?	N/A
N/A	Landing Width (in)	N/A	N/A	DWS Contrast?	N/A
N/A	Landing Slope (%)	N/A	N/A	DWS Length (in)	N/A
N/A	Landing X Slope (%)	N/A	N/A	DWS Full Width?	N/A
N/A	Landing Curb? (Y/N)	N/A	N/A	DWS Offset (in)	N/A
N/A	Shared Landing?	N/A			
N/A	Gutter Ponding?	N/A	N/A	Gutter Slope (%)	N/A
N/A	Gutter Lip Ht (in)	N/A	N/A	Gutter X Slope (%)	N/A
N/A	Painted X Walk1?	No	N/A	Painted X Walk2?	No
	X Walk 1 Direction	To SE		X Walk 2 Direction	To NE
N/A	X Walk 1 Width (in)	N/A	N/A	X Walk 2 Width (in)	N/A
	X Walk 1 Slope (%)	7.4		X Walk 2 Slope (%)	10.5
	X Walk 1 X Slope (%)	6.8		X Walk 2 X Slope (%)	4.8

N/A	Ramp inside XWalk1?	N/A	N/A	Ramp inside XWalk2?	N/A
	Road Slope (%)	1.6	N/A	Clear Space?	N/A
	Road X Slope (%)	11.5	N/A	Clear Space to XWalk (in)	N/A
N/A	Any Obstructions?	N/A	N/A	Storm Grate/Utility Hazard?	N/A
	Obstruction Type			Storm Grate/Utility Type	
		N/A			N/A
			Yes	Surface Condition? (G/P)	Good

Remove & Replace Curb Ramp With Two New Directional Ramps or Equivalent.
