Access Compliance Report

Public Rights-of-Way

(Curb Ramps)

Intersection ID: 26392	Main Street: BEVINGTON_PL	Cross Street: BRECHIN_DR	Location: SE
ADA ID: 7C1465562805	Ramp Type: Perp	Initial Pass/Fail: Fail	Overall Compliance: No
Severity Score: 31.25			
Codes/Mitigation Info/Possible Solution		Field Measurements/Component Compliance

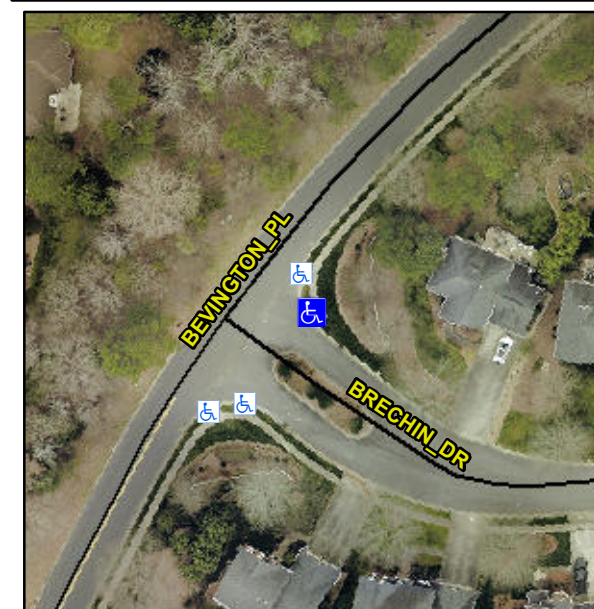
R304.5.1, R304.2.2, R304.5.3

Compliance	Description	Data	Compliance	Description	Data
N/A	Ramp Length (in)	96.0	No	Ramp Slope (%)	9.3
No	Ramp Width (in)	34.0	No	Ramp XSlope (%)	2.4
N/A	Flare Type LT	N/A	N/A	Flare Type RT	N/A
N/A	Flare Slope LT (%)	N/A	N/A	Flare Slope RT (%)	N/A
N/A	Flare Traversable LT?	N/A	N/A	Flare Traversable RT?	N/A
N/A	Landing Length (in)	N/A	N/A	DWS Provided?	N/A
N/A	Landing Width (in)	N/A	N/A	DWS Contrast?	N/A
N/A	Landing Slope (%)	N/A	N/A	DWS Length (in)	N/A
N/A	Landing X Slope (%)	N/A	N/A	DWS Full Width?	N/A
N/A	Landing Curb? (Y/N)	N/A	N/A	DWS Offset (in)	N/A
N/A	Shared Landing?	N/A			
N/A	Gutter Ponding?	N/A	N/A	Gutter Slope (%)	N/A
N/A	Gutter Lip Ht (in)	N/A	N/A	Gutter X Slope (%)	N/A
N/A	Painted X Walk1?	No	N/A	Painted X Walk2?	N/A
	X Walk 1 Direction	To SW		X Walk 2 Direction	N/A
N/A	X Walk 1 Width (in)	N/A	N/A	X Walk 2 Width (in)	N/A
	X Walk 1 Slope (%)	0.3		X Walk 2 Slope (%)	N/A
	X Walk 1 X Slope (%)	2.1		X Walk 2 X Slope (%)	N/A

Possible Solutions:

Remove & Replace Entire Ramp.

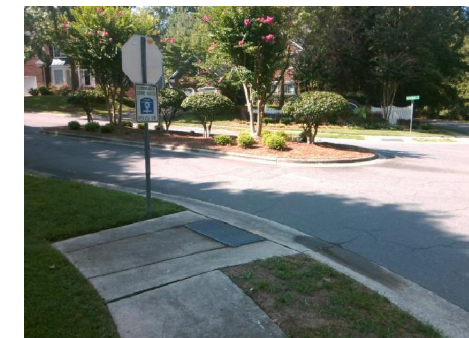
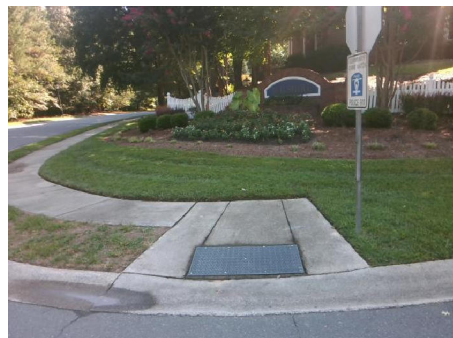
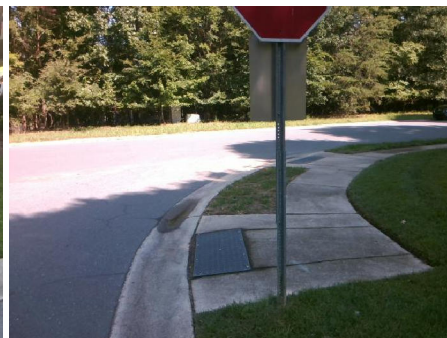
N/A	Ramp inside XWalk1?	N/A	N/A	Ramp inside XWalk2?	N/A
	Road Slope (%)	N/A	N/A	Clear Space?	N/A
	Road X Slope (%)	N/A	N/A	Clear Space to XWalk (in)	N/A
N/A	Any Obstructions?	N/A	N/A	Storm Grate/Utility Hazard?	N/A
	Obstruction Type			Storm Grate/Utility Type	
		N/A			N/A
			Yes	Surface Condition? (G/P)	Good
