# Access Compliance Report

## Public Rights-of-Way

### (Curb Ramps)

Intersection ID: 10747	Main Street: DUCKWORTH_AV	Cross Street: S_BRUNS_AV	Location: SW
ADA ID: 7C25FC9E703E	Ramp Type: PerpDiag	Initial Pass/Fail: Fail	Overall Compliance: No
Severity Score: 61.25			
Codes/Mitigation Info/Possible Solution		Field Measurements/Component Compliance

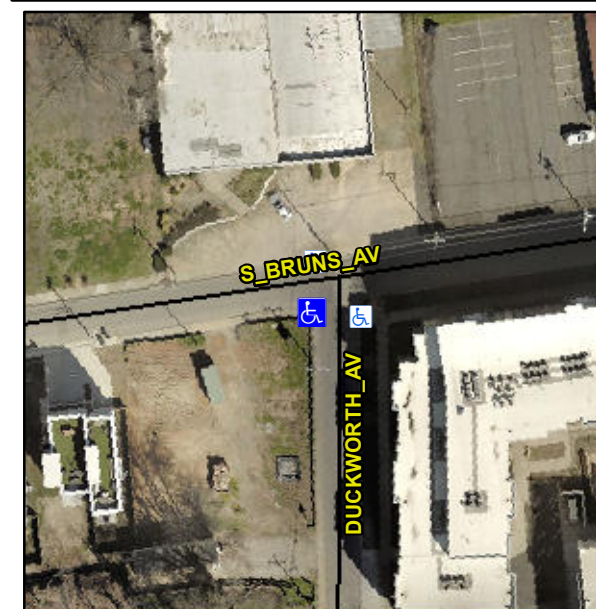
**Not Found, R304.5.1, R304.2.2, R304.5.3**

Compliance	Description	Data	Compliance	Description	Data
N/A	Ramp Length (in)	48.0	No	Ramp Slope (%)	12.0
No	Ramp Width (in)	30.0	No	Ramp XSlope (%)	3.9
N/A	Flare Type LT	N/A	N/A	Flare Type RT	N/A
N/A	Flare Slope LT (%)	N/A	N/A	Flare Slope RT (%)	N/A
N/A	Flare Traversable LT?	N/A	N/A	Flare Traversable RT?	N/A
N/A	Landing Length (in)	N/A	N/A	DWS Provided?	N/A
N/A	Landing Width (in)	N/A	N/A	DWS Contrast?	N/A
N/A	Landing Slope (%)	N/A	N/A	DWS Length (in)	N/A
N/A	Landing X Slope (%)	N/A	N/A	DWS Full Width?	N/A
N/A	Landing Curb? (Y/N)	N/A	N/A	DWS Offset (in)	N/A
N/A	Shared Landing?	N/A			
N/A	Gutter Ponding?	N/A	N/A	Gutter Slope (%)	N/A
N/A	Gutter Lip Ht (in)	2.0	N/A	Gutter X Slope (%)	N/A
N/A	Painted X Walk1?	No	N/A	Painted X Walk2?	No
	X Walk 1 Direction	To E		X Walk 2 Direction	To N
N/A	X Walk 1 Width (in)	N/A	N/A	X Walk 2 Width (in)	N/A
	X Walk 1 Slope (%)	1.3		X Walk 2 Slope (%)	6.2
	X Walk 1 X Slope (%)	5.5		X Walk 2 X Slope (%)	1.4

**Remove & Replace Curb Ramp With Two New Directional Ramps or Equivalent.**

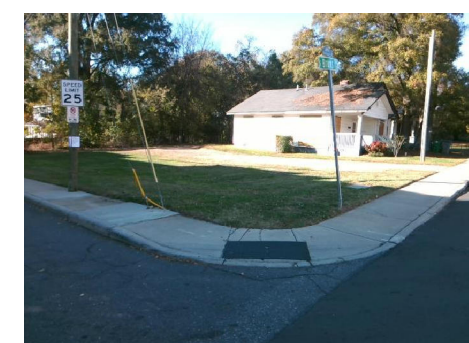
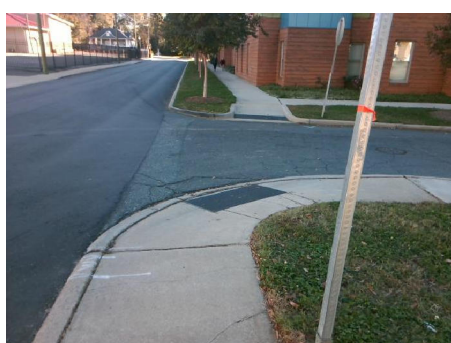
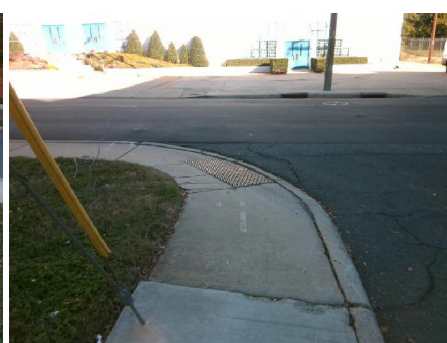
N/A	Ramp inside XWalk1?	N/A	N/A	Ramp inside XWalk2?	N/A
	Road Slope (%)	5.9	N/A	Clear Space?	N/A
	Road X Slope (%)	2.2	N/A	Clear Space to XWalk (in)	N/A
N/A	Any Obstructions?	N/A	N/A	Storm Grate/Utility Hazard?	N/A
	Obstruction Type			Storm Grate/Utility Type	
		N/A			N/A
			Yes	Surface Condition? (G/P)	Good
