Access Compliance Report

Public Rights-of-Way

(Curb Ramps)

Intersection ID: 14299	Main Street: N_I-77_EXIT_8_RA	Cross Street: REMOUNT_RD	Location: W
ADA ID: 7C305FC590C5	Ramp Type: PerpDiag	Initial Pass/Fail: Fail	Overall Compliance: No
Severity Score: 13.75			
Codes/Mitigation Info/Possible Solution		Field Measurements/Component Compliance

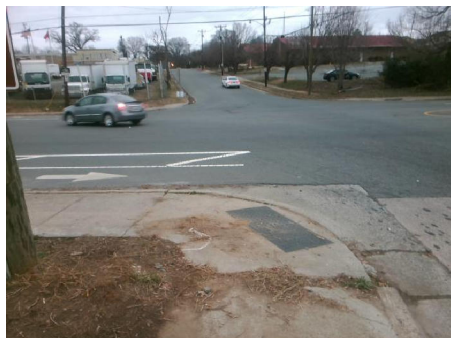
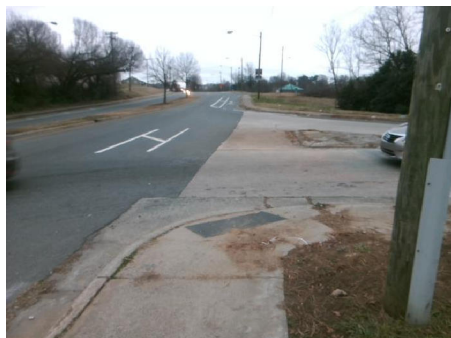
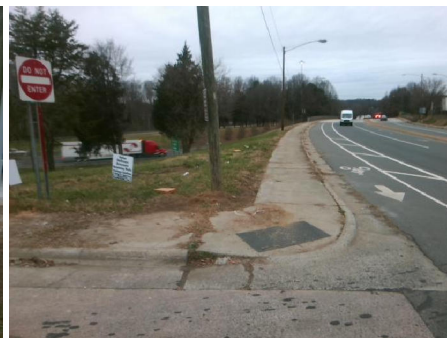
Not Found, R304.2.2, R304.5.3

Compliance	Description	Data	Compliance	Description	Data
N/A	Ramp Length (in)	67.0	No	Ramp Slope (%)	9.9
Yes	Ramp Width (in)	48.0	No	Ramp XSlope (%)	2.1
N/A	Flare Type LT	N/A	N/A	Flare Type RT	N/A
N/A	Flare Slope LT (%)	N/A	N/A	Flare Slope RT (%)	N/A
N/A	Flare Traversable LT?	N/A	N/A	Flare Traversable RT?	N/A
N/A	Landing Length (in)	N/A	N/A	DWS Provided?	N/A
N/A	Landing Width (in)	N/A	N/A	DWS Contrast?	N/A
N/A	Landing Slope (%)	N/A	N/A	DWS Length (in)	N/A
N/A	Landing X Slope (%)	N/A	N/A	DWS Full Width?	N/A
N/A	Landing Curb? (Y/N)	N/A	N/A	DWS Offset (in)	N/A
N/A	Shared Landing?	N/A			
N/A	Gutter Ponding?	N/A	N/A	Gutter Slope (%)	N/A
N/A	Gutter Lip Ht (in)	N/A	N/A	Gutter X Slope (%)	N/A
N/A	Painted X Walk1?	No	N/A	Painted X Walk2?	No
	X Walk 1 Direction	To S		X Walk 2 Direction	To NE
N/A	X Walk 1 Width (in)	N/A	N/A	X Walk 2 Width (in)	N/A
	X Walk 1 Slope (%)	2.5		X Walk 2 Slope (%)	4.6
	X Walk 1 X Slope (%)	1.6		X Walk 2 X Slope (%)	1.7

N/A	Ramp inside XWalk1?	N/A	N/A	Ramp inside XWalk2?	N/A
	Road Slope (%)	1.4	N/A	Clear Space?	N/A
	Road X Slope (%)	1.7	N/A	Clear Space to XWalk (in)	N/A
N/A	Any Obstructions?	N/A	N/A	Storm Grate/Utility Hazard?	N/A
	Obstruction Type			Storm Grate/Utility Type	
		N/A			N/A
		Yes		Surface Condition? (G/P)	Good

Remove & Replace Curb Ramp With Two New Directional Ramps or Equivalent.
