Access Compliance Report Public Rights-of-Way (Curb Ramps)

Intersection ID: 10033787Main Street: PACIFIC_ECHO_DRCross Street: N/ALocation:NWADA ID: 7C32C8C4F419Ramp Type: PerpInitial Pass/Fail: FailOverall Compliance: NoSeverity Score: 13.75

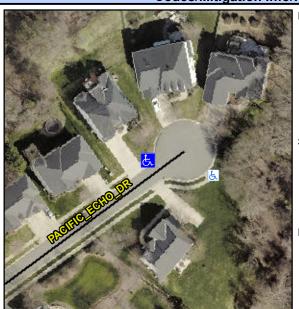
Field Measurements/Component Compliance									
Compliance Description		Data	Comp	liance Description	Data				
N/A	Ramp Length (in)	47.0	No	Ramp Slope (%)	10.7				
Yes	Ramp Width (in)	49.0	No	Ramp XSlope (%)	2.9				
N/A	Flare Type LT	N/A	N/A	Flare Type RT	N/A				
N/A	Flare Slope LT (%)	N/A	N/A	Flare Slope RT (%)	N/A				
N/A	Flare Traversable LT?	N/A	N/A	Flare Traversable RT?	N/A				
N/A	Landing Length (in)	N/A	N/A	DWS Provided?	N/A				
N/A	Landing Width (in)	N/A	N/A	DWS Contrast?	N/A				
N/A	Landing Slope (%)	N/A	N/A	DWS Length (in)	N/A				
N/A	Landing X Slope (%)	N/A	N/A	DWS Full Width?	N/A				
N/A	Landing Curb? (Y/N)	N/A	N/A	DWS Offset (in)	N/A				
N/A	Shared Landing?	N/A							
N/A	Gutter Ponding?	N/A	N/A	Gutter Slope (%)	N/A				
N/A	Gutter Lip Ht (in)	N/A	N/A	Gutter X Slope (%)	N/A				
N/A	Painted X Walk1?	No	N/A	Painted X Walk2?	N/A				
	X Walk 1 Direction	To SE		X Walk 2 Direction	N/A				
N/A	X Walk 1 Width (in)	N/A	N/A	X Walk 2 Width (in)	N/A

X Walk 1 Slope (%)	3.6		X Walk 2 Slope (%)	N/A				
	X Walk 1 X Slope (%)	1.9		X Walk 2 X Slope (%)	N/A				
N/A	Ramp inside XWalk1?	N/A	N/A	Ramp inside XWalk2?	N/A				
	Road Slope (%)	N/A	N/A	Clear Space?	N/A				
	Road X Slope (%)	N/A	N/A	Clear Space to XWalk (in)	N/A				
N/A	Any Obstructions?	N/A	N/A	Storm Grate/Utility Hazard?	N/A				
	Obstruction Type			Storm Grate/Utility Type					
		N/A			N/A				
			Yes	Surface Condition? (G/P)	Good

ř	Possible Solutions:							
The state of the s	Remove & Replace Entire Ramp.							
A STATE OF THE PARTY OF THE PARTY OF	Surveyor Notes:							
	PROW/ADA: Not Found, R304.2.2, R304.5.3							
A 100 COL
