Access Compliance Report

Public Rights-of-Way

(Curb Ramps)

| Intersection ID: 18769 | Main Street: BARCLAY_DOWNS_DR | Cross Street: RUNNYMEDE_LN | Location: SW |

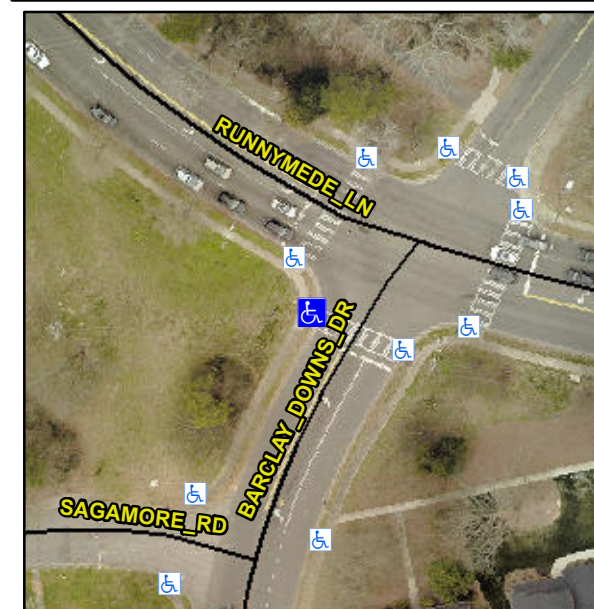
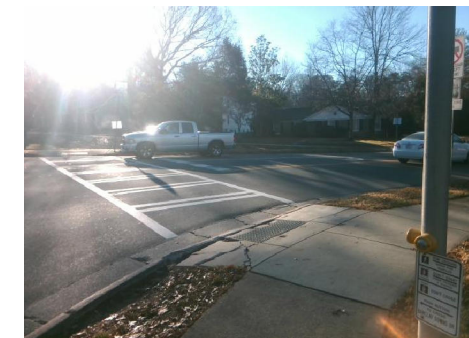
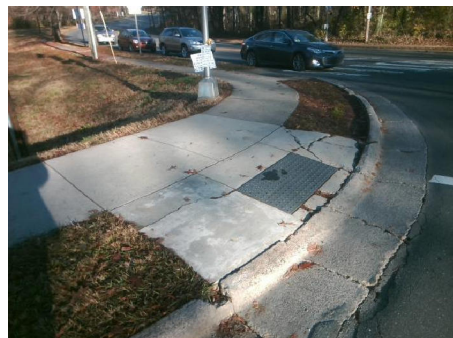
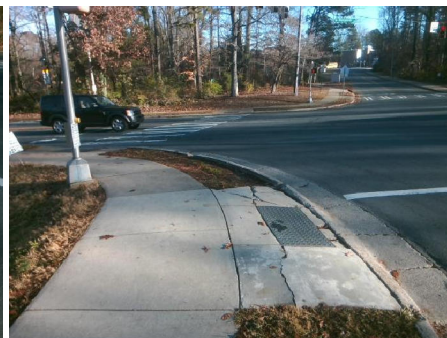
Not Found, R304.5.1, R304.2.2, R302.7

| Compliance | Description | Data | Compliance | Description | Data |
|---|---|---|---|---|---|
| N/A | Ramp Length (in) | 50.0 | No | Ramp Slope (%) | 11.2 |
| No | Ramp Width (in) | 47.0 | Yes | Ramp XSlope (%) | 1.8 |
| | | No | | Surface Condition? (G/P) | Poor |

Remove & Replace Entire Ramp.
