Access Compliance Report

Public Rights-of-Way

(Curb Ramps)

Intersection ID: 3825	Main Street: GARRISON_RD	Cross Street: LADORA_DR	Location:	N
ADA ID: 7C51929A0EA0	Ramp Type: PerpDiag	Initial Pass/Fail: Fail	Overall Compliance: No	Severity Score: 17.5
Codes/Mitigation Info/Possible Solution		Field Measurements/Component Compliance

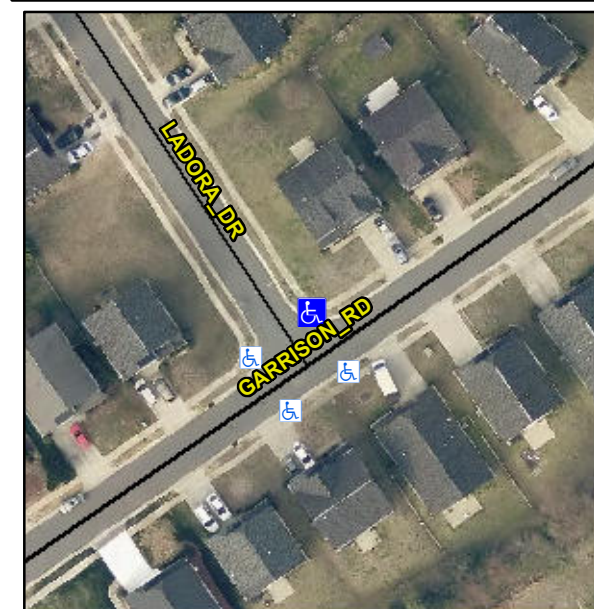
Not Found, R304.5.1

Compliance	Description	Data	Compliance	Description	Data
N/A	Ramp Length (in)	48.5	Yes	Ramp Slope (%)	6.6
No	Ramp Width (in)	35.0	Yes	Ramp XSlope (%)	1.0
N/A	Flare Type LT	N/A	N/A	Flare Type RT	N/A
N/A	Flare Slope LT (%)	N/A	N/A	Flare Slope RT (%)	N/A
N/A	Flare Traversable LT?	N/A	N/A	Flare Traversable RT?	N/A
N/A	Landing Length (in)	N/A	N/A	DWS Provided?	N/A
N/A	Landing Width (in)	N/A	N/A	DWS Contrast?	N/A
N/A	Landing Slope (%)	N/A	N/A	DWS Length (in)	N/A
N/A	Landing X Slope (%)	N/A	N/A	DWS Full Width?	N/A
N/A	Landing Curb? (Y/N)	N/A	N/A	DWS Offset (in)	N/A
N/A	Shared Landing?	N/A			
N/A	Gutter Ponding?	N/A	N/A	Gutter Slope (%)	N/A
N/A	Gutter Lip Ht (in)	N/A	N/A	Gutter X Slope (%)	N/A
N/A	Painted X Walk1?	No	N/A	Painted X Walk2?	No
	X Walk 1 Direction	To SW		X Walk 2 Direction	To SE
N/A	X Walk 1 Width (in)	N/A	N/A	X Walk 2 Width (in)	N/A
	X Walk 1 Slope (%)	4.8		X Walk 2 Slope (%)	2.7
	X Walk 1 X Slope (%)	0.5		X Walk 2 X Slope (%)	2.4

N/A	Ramp inside XWalk1?	N/A	N/A	Ramp inside XWalk2?	N/A
	Road Slope (%)	0.5	N/A	Clear Space?	N/A
	Road X Slope (%)	3.1	N/A	Clear Space to XWalk (in)	N/A
N/A	Any Obstructions?	N/A	N/A	Storm Grate/Utility Hazard?	N/A
	Obstruction Type			Storm Grate/Utility Type	
		N/A			N/A
			Yes	Surface Condition? (G/P)	Good

Remove & Replace Curb Ramp With Two New Directional Ramps or Equivalent.
