Access Compliance Report

Public Rights-of-Way

(Curb Ramps)

Intersection ID: 27397	Main Street: ELM_LN	Cross Street: BALLANTYNE_COMMONS_PY	Location: NE
ADA ID: 7C549BC92A1E	Ramp Type: Perp	Initial Pass/Fail: Fail	Overall Compliance: No
		Severity Score: 22.5

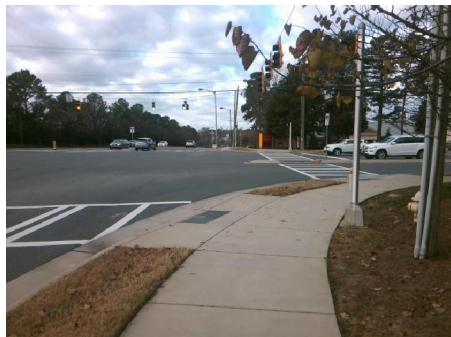
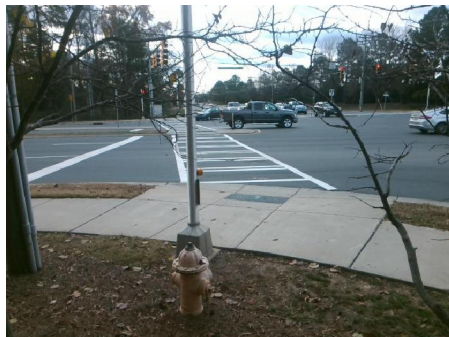
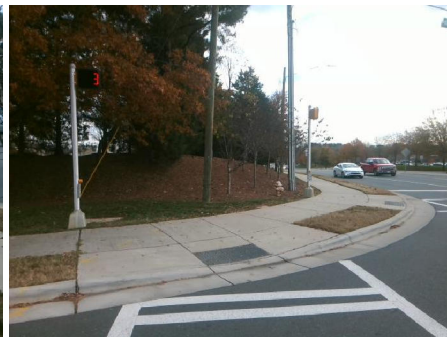
Not Found, R304.5.1, R304.2.2, R304.5.3

Compliance	Description	Data	Compliance	Description	Data
N/A	Ramp Length (in)	47.0	No	Ramp Slope (%)	8.7
No	Ramp Width (in)	46.5	No	Ramp XSlope (%)	4.7
N/A	Flare Type LT	N/A	N/A	Flare Type RT	N/A
N/A	Flare Slope LT (%)	N/A	N/A	Flare Slope RT (%)	N/A
N/A	Flare Traversable LT?	N/A	N/A	Flare Traversable RT?	N/A
N/A	Landing Length (in)	N/A	N/A	DWS Provided?	N/A
N/A	Landing Width (in)	N/A	N/A	DWS Contrast?	N/A
N/A	Landing Slope (%)	N/A	N/A	DWS Length (in)	N/A
N/A	Landing X Slope (%)	N/A	N/A	DWS Full Width?	N/A
N/A	Landing Curb? (Y/N)	N/A	N/A	DWS Offset (in)	N/A
N/A	Shared Landing?	N/A			
N/A	Gutter Ponding?	N/A	N/A	Gutter Slope (%)	N/A
N/A	Gutter Lip Ht (in)	N/A	N/A	Gutter X Slope (%)	N/A
N/A	Painted X Walk1?	Yes	N/A	Painted X Walk2?	N/A
	X Walk 1 Direction	To SE		X Walk 2 Direction	N/A
N/A	X Walk 1 Width (in)	112.0	N/A	X Walk 2 Width (in)	N/A
	X Walk 1 Slope (%)	0.8		X Walk 2 Slope (%)	N/A
	X Walk 1 X Slope (%)	2.4		X Walk 2 X Slope (%)	N/A

N/A	Ramp inside XWalk1?	Yes	N/A	Ramp inside XWalk2?	N/A
	Road Slope (%)	N/A	N/A	Clear Space?	N/A
	Road X Slope (%)	N/A	N/A	Clear Space to XWalk (in)	N/A
N/A	Any Obstructions?	N/A	N/A	Storm Grate/Utility Hazard?	N/A
	Obstruction Type			Storm Grate/Utility Type	
		N/A			N/A
			Yes	Surface Condition? (G/P)	Good

Remove & Replace Entire Ramp.
