# Access Compliance Report

## Public Rights-of-Way

### (Curb Ramps)

| Intersection ID: 53090 | Main Street: BRADFORD_HALL_PL | Cross Street: DEERFIELD_MANOR_DR | Location: | S |

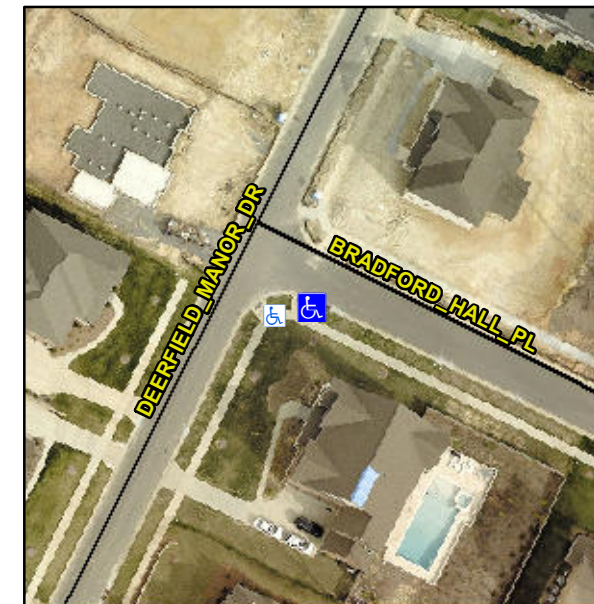
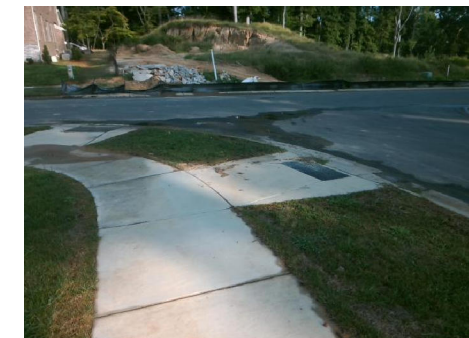
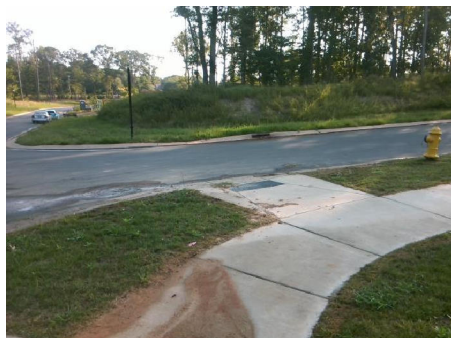
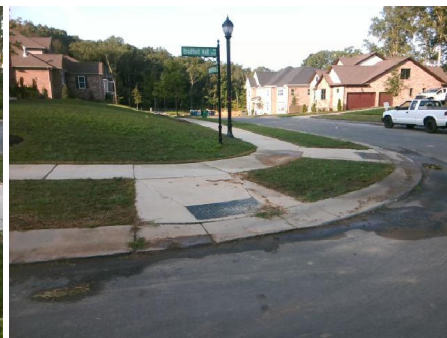
| ADA ID: 7C571D1EDE48 | Ramp Type: Perp | Initial Pass/Fail: Fail | Overall Compliance: No | Severity Score: 10 |

| Compliance | Description | Data | Compliance | Description | Data |
|---|---|---|---|---|---|
| N/A | Ramp Length (in) | 95.0 | Yes | Ramp Slope (%) | 5.2 |
| No | Ramp Width (in) | 45.5 | No | Ramp XSlope (%) | 4.6 |

**Remove & Replace Entire Ramp.**

**R304.5.1, R304.5.3**

Total Cost: \$ 1850.00
