Access Compliance Report

Public Rights-of-Way

| Intersection ID: 22879 | Main Street: MOSS_RD | Cross Street: IMPERIAL_OAK_LN | Location: SE |
| ADA ID: 7C599D419CB5 | Ramp Type: Perp | Initial Pass/Fail: Fail | Overall Compliance: No |

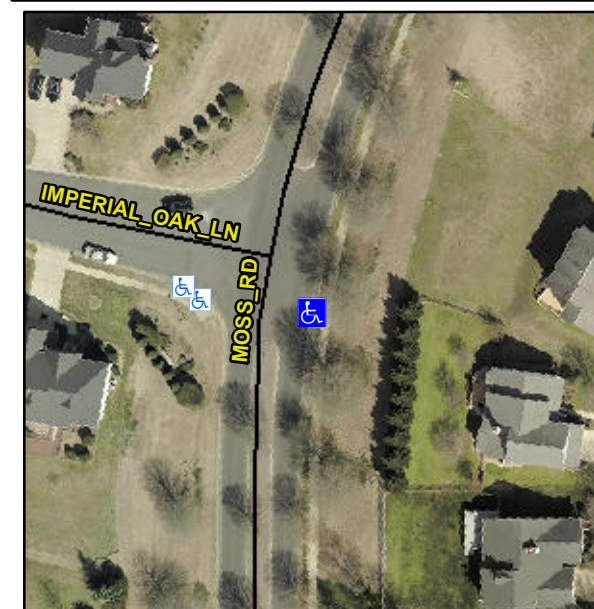
Not Found, R304.2.2, R304.5.3

| Compliance | Description | Data | Compliance | Description | Data |
|---|---|---|---|---|---|
| N/A | Ramp Length (in) | 47.0 | No | Ramp Slope (%) | 16.0 |
| Yes | Ramp Width (in) | 48.0 | No | Ramp XSlope (%) | 3.3 |

Remove & Replace Entire Ramp.

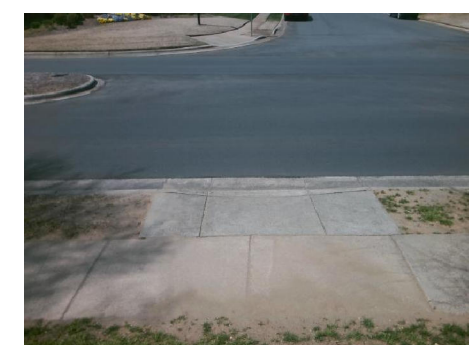
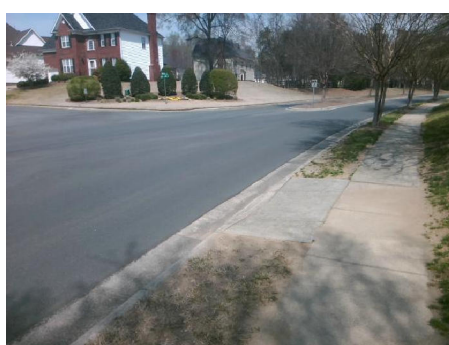
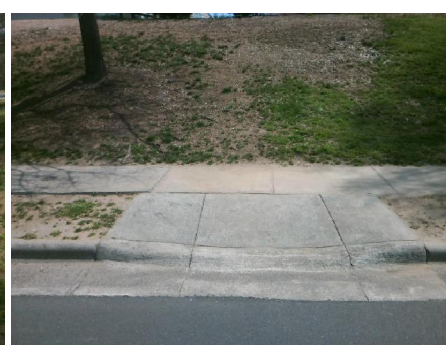
| Compliance | Description | Data | Compliance | Description | Data |
|---|---|---|---|---|---|
| | | | Yes | Surface Condition? (G/P) | Good |
