# Access Compliance Report

## Public Rights-of-Way

### (Curb Ramps)

Intersection ID: 42772	Main Street: JEANETTE_CR	Cross Street: SWANSONG_LN	Location:	N
ADA ID: 7C5EF171FAFE	Ramp Type: PerpDiag	Initial Pass/Fail: Fail	Overall Compliance: No	Severity Score: 10
Codes/Mitigation Info/Possible Solution		Field Measurements/Component Compliance

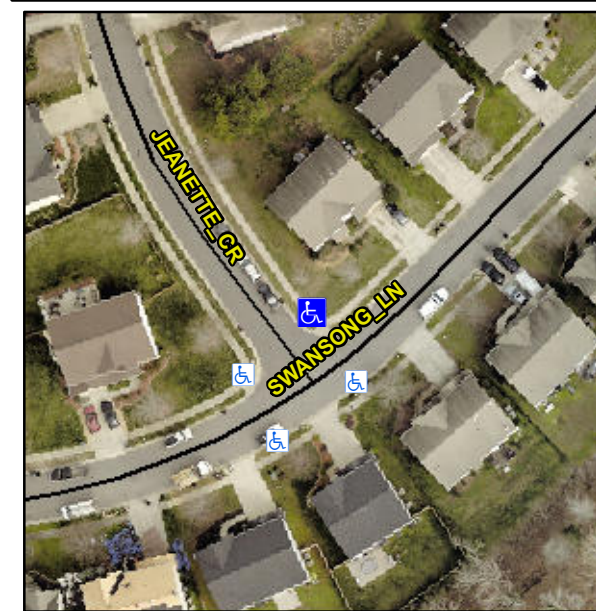
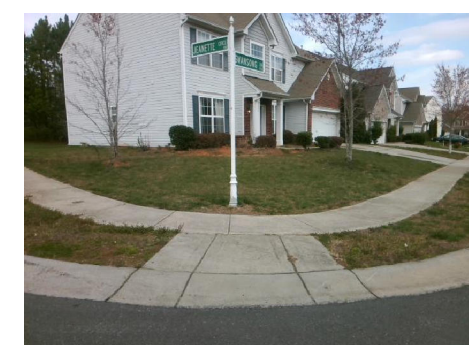
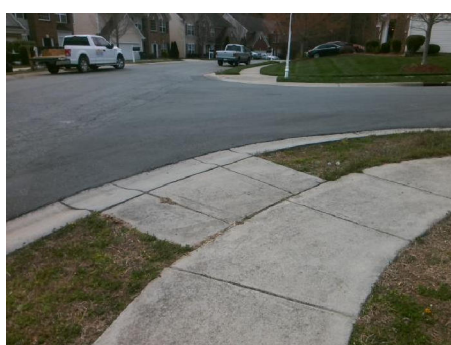
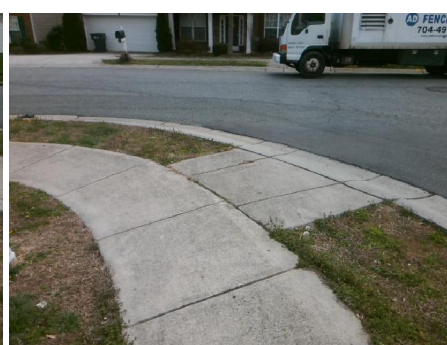
**Not Found, R304.5.1, R304.5.3**

Compliance	Description	Data	Compliance	Description	Data
N/A	Ramp Length (in)	48.0	Yes	Ramp Slope (%)	5.1
No	Ramp Width (in)	38.0	No	Ramp XSlope (%)	4.8
N/A	Flare Type LT	N/A	N/A	Flare Type RT	N/A
N/A	Flare Slope LT (%)	N/A	N/A	Flare Slope RT (%)	N/A
N/A	Flare Traversable LT?	N/A	N/A	Flare Traversable RT?	N/A
N/A	Landing Length (in)	N/A	N/A	DWS Provided?	N/A
N/A	Landing Width (in)	N/A	N/A	DWS Contrast?	N/A
N/A	Landing Slope (%)	N/A	N/A	DWS Length (in)	N/A
N/A	Landing X Slope (%)	N/A	N/A	DWS Full Width?	N/A
N/A	Landing Curb? (Y/N)	N/A	N/A	DWS Offset (in)	N/A
N/A	Shared Landing?	N/A			
N/A	Gutter Ponding?	N/A	N/A	Gutter Slope (%)	N/A
N/A	Gutter Lip Ht (in)	N/A	N/A	Gutter X Slope (%)	N/A
N/A	Painted X Walk1?	No	N/A	Painted X Walk2?	No
	X Walk 1 Direction	To SW		X Walk 2 Direction	To SE
N/A	X Walk 1 Width (in)	N/A	N/A	X Walk 2 Width (in)	N/A
	X Walk 1 Slope (%)	3.7		X Walk 2 Slope (%)	0.5
	X Walk 1 X Slope (%)	1.1		X Walk 2 X Slope (%)	2.4

N/A	Ramp inside XWalk1?	N/A	N/A	Ramp inside XWalk2?	N/A
	Road Slope (%)	5.0	N/A	Clear Space?	N/A
	Road X Slope (%)	1.9	N/A	Clear Space to XWalk (in)	N/A
N/A	Any Obstructions?	N/A	N/A	Storm Grate/Utility Hazard?	N/A
	Obstruction Type			Storm Grate/Utility Type	
		N/A			N/A
			Yes	Surface Condition? (G/P)	Good

**Remove & Replace Curb Ramp With Two New Directional Ramps or Equivalent.**
