Access Compliance Report

Public Rights-of-Way

(Curb Ramps)

Intersection ID: 21206	Main Street: NORTHAMPTON_DR	Cross Street: PARK_RD	Location:	W
ADA ID: 7C7125AB0A7A	Ramp Type: PerpDiag	Initial Pass/Fail: Fail	Overall Compliance: No	Severity Score: 12.5

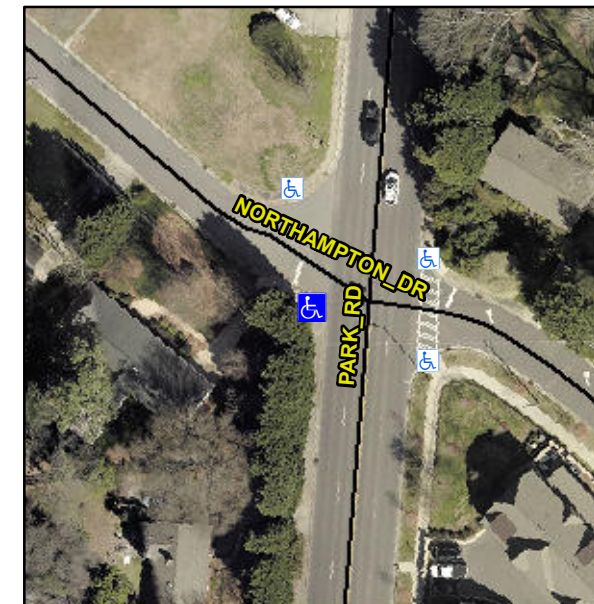
Not Found, R304.2.2

Compliance	Description	Data	Compliance	Description	Data
N/A	Ramp Length (in)	58.0	No	Ramp Slope (%)	8.5
Yes	Ramp Width (in)	48.0	Yes	Ramp XSlope (%)	1.9
N/A	Flare Type LT	N/A	N/A	Flare Type RT	N/A
N/A	Flare Slope LT (%)	N/A	N/A	Flare Slope RT (%)	N/A
N/A	Flare Traversable LT?	N/A	N/A	Flare Traversable RT?	N/A
N/A	Landing Length (in)	N/A	N/A	DWS Provided?	N/A
N/A	Landing Width (in)	N/A	N/A	DWS Contrast?	N/A
N/A	Landing Slope (%)	N/A	N/A	DWS Length (in)	N/A
N/A	Landing X Slope (%)	N/A	N/A	DWS Full Width?	N/A
N/A	Landing Curb? (Y/N)	N/A	N/A	DWS Offset (in)	N/A
N/A	Shared Landing?	N/A			
N/A	Gutter Ponding?	N/A	N/A	Gutter Slope (%)	N/A
N/A	Gutter Lip Ht (in)	N/A	N/A	Gutter X Slope (%)	N/A
N/A	Painted X Walk1?	No	N/A	Painted X Walk2?	No
	X Walk 1 Direction	To SE		X Walk 2 Direction	To N
N/A	X Walk 1 Width (in)	N/A	N/A	X Walk 2 Width (in)	N/A
	X Walk 1 Slope (%)	1.2		X Walk 2 Slope (%)	1.4
	X Walk 1 X Slope (%)	1.9		X Walk 2 X Slope (%)	0.4

N/A	Ramp inside XWalk1?	N/A	N/A	Ramp inside XWalk2?	N/A
	Road Slope (%)	0.1	N/A	Clear Space?	N/A
	Road X Slope (%)	0.6	N/A	Clear Space to XWalk (in)	N/A
N/A	Any Obstructions?	N/A	N/A	Storm Grate/Utility Hazard?	N/A
	Obstruction Type			Storm Grate/Utility Type	
		N/A			N/A
			Yes	Surface Condition? (G/P)	Good

Possible Solutions:

Remove & Replace Curb Ramp With Two New Directional Ramps or Equivalent.
