Access Compliance Report

Public Rights-of-Way

(Curb Ramps)

Intersection ID: N/A	Main Street: BEREWICK_TOWN_CENTRE	Cross Street: CADEN_RD	Location: SW
ADA ID: 7C8D98A0A8AD	Ramp Type: Perp	Initial Pass/Fail: Fail	Overall Compliance: No
Severity Score: 1.25			
Codes/Mitigation Info/Possible Solution		Field Measurements/Component Compliance

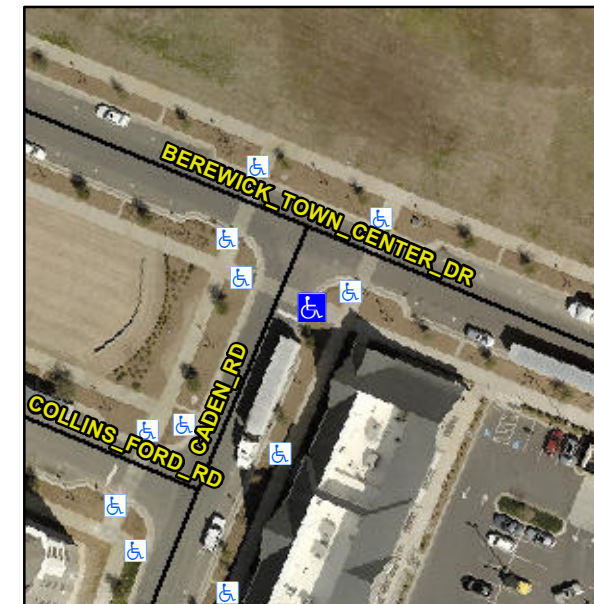
Not Found, R304.5.3

Compliance	Description	Data	Compliance	Description	Data
N/A	Ramp Length (in)	176.0	Yes	Ramp Slope (%)	6.5
Yes	Ramp Width (in)	94.0	No	Ramp XSlope (%)	2.4
N/A	Flare Type LT	N/A	N/A	Flare Type RT	N/A
N/A	Flare Slope LT (%)	N/A	N/A	Flare Slope RT (%)	N/A
N/A	Flare Traversable LT?	N/A	N/A	Flare Traversable RT?	N/A
N/A	Landing Length (in)	N/A	N/A	DWS Provided?	N/A
N/A	Landing Width (in)	N/A	N/A	DWS Contrast?	N/A
N/A	Landing Slope (%)	N/A	N/A	DWS Length (in)	N/A
N/A	Landing X Slope (%)	N/A	N/A	DWS Full Width?	N/A
N/A	Landing Curb? (Y/N)	N/A	N/A	DWS Offset (in)	N/A
N/A	Shared Landing?	N/A			
N/A	Gutter Ponding?	N/A	N/A	Gutter Slope (%)	N/A
N/A	Gutter Lip Ht (in)	N/A	N/A	Gutter X Slope (%)	N/A
N/A	Painted X Walk1?	Yes	N/A	Painted X Walk2?	N/A
	X Walk 1 Direction	To NW		X Walk 2 Direction	N/A
N/A	X Walk 1 Width (in)	98.0	N/A	X Walk 2 Width (in)	N/A
	X Walk 1 Slope (%)	1.1		X Walk 2 Slope (%)	N/A
	X Walk 1 X Slope (%)	1.7		X Walk 2 X Slope (%)	N/A

Remove & Replace Entire Ramp.

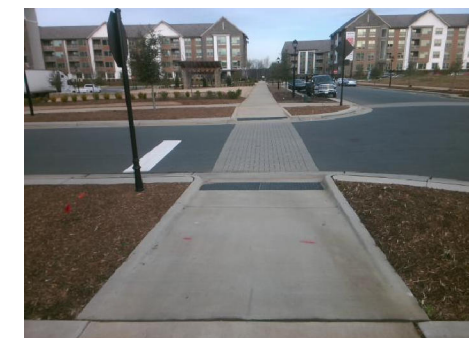
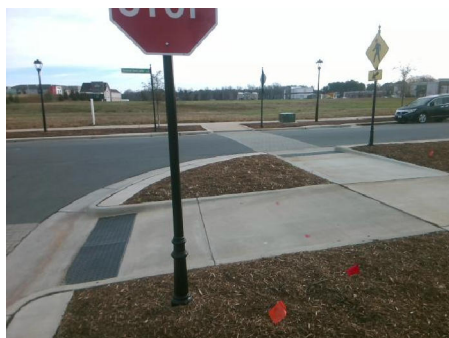
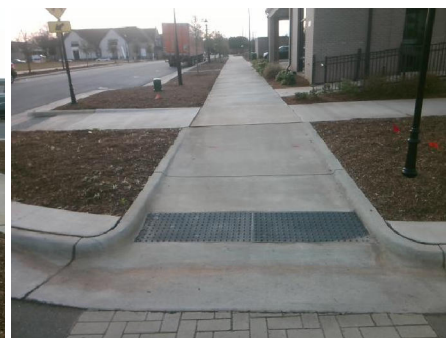
N/A	Ramp inside XWalk1?	Yes	N/A	Ramp inside XWalk2?	N/A
	Road Slope (%)	N/A	N/A	Clear Space?	N/A
	Road X Slope (%)	N/A	N/A	Clear Space to XWalk (in)	N/A
N/A	Any Obstructions?	N/A	N/A	Storm Grate/Utility Hazard?	N/A
	Obstruction Type			Storm Grate/Utility Type	
		N/A			N/A
		Yes		Surface Condition? (G/P)	Good
