# Access Compliance Report

## Public Rights-of-Way

### (Curb Ramps)

Intersection ID: 8375	Main Street: HOOD_RD	Cross Street: STEEPLETON_WY	Location:	N
ADA ID: 7C902ACEC3A7	Ramp Type: Perp	Initial Pass/Fail: Fail	Overall Compliance: No	Severity Score: 35

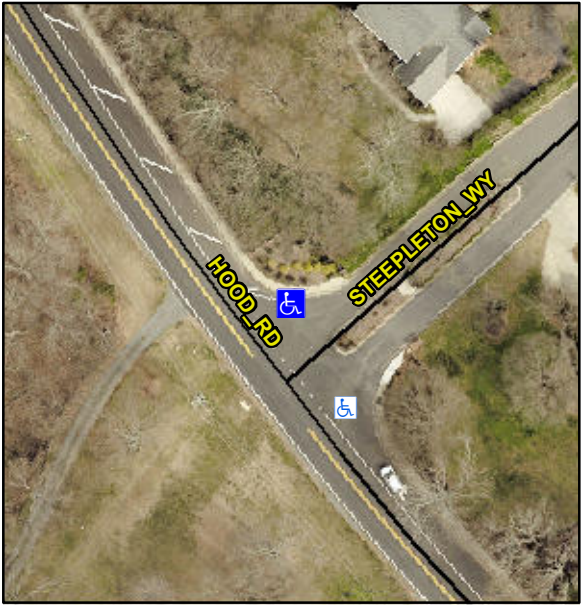
<p>Street 1 Name                      <b>STEEPLETON WY</b></p> <p>Stop Condition-Street 2              <b>StopSign</b></p> <p>Street 2 Name                      <b>N/A</b></p> <p>Stop Condition-Street 1              <b>N/A</b></p>	Possible Solutions:		<b>Compliance</b>	<b>Description</b>	<b>Data</b>
	<b>Remove &amp; Replace Entire Ramp.</b>		<b>No</b>	Ramp Length (in)	<b>48.0</b>
			<b>No</b>	Ramp Width (in)	<b>36.0</b>
			<b>N/A</b>	Flare Type LT	<b>N/A</b>
			<b>N/A</b>	Flare Slope LT (%)	<b>N/A</b>
			<b>N/A</b>	Flare Traversable LT?	<b>N/A</b>
			<b>N/A</b>	Landing Length (in)	<b>N/A</b>
			<b>N/A</b>	Landing Width (in)	<b>N/A</b>
			<b>N/A</b>	Landing Slope (%)	<b>N/A</b>
			<b>N/A</b>	Landing X Slope (%)	<b>N/A</b>
			<b>N/A</b>	Landing Curb? (Y/N)	<b>N/A</b>
			<b>N/A</b>	Shared Landing?	<b>N/A</b>
			<b>N/A</b>	Gutter Ponding?	<b>N/A</b>

<b>N/A</b>	Gutter Lip Ht (in)	<b>N/A</b>
			<b>No</b>	Painted X Walk1?	<b>N/A</b>
				X Walk 1 Direction	<b>To S</b>
			<b>N/A</b>	X Walk 1 Width (in)	<b>N/A</b>
				X Walk 1 Slope (%)	<b>2.2</b>
				X Walk 1 X Slope (%)	<b>2.5</b>
			<b>N/A</b>	Ramp inside XWalk1?	<b>N/A</b>
<p>Surveyor Notes:</p> <p><b>N/A</b></p> <p>PROW/ADA:</p> <p><b>Not Found, R304.5.1, R304.2.2, R304.5.3</b></p>			<b>N/A</b>	Road Slope (%)	<b>N/A</b>
			<b>N/A</b>	Road X Slope (%)	<b>N/A</b>
			<b>N/A</b>	Any Obstructions?	<b>N/A</b>
				Obstruction Type	
			<b>N/A</b>		<b>N/A</b>
			<b>Yes</b>	Surface Condition? (G/P)	<b>Good</b>

Total Cost: \$ 1850.00
