Intersection ID: 2491	Main Street: LYNNEWOOD_GLEN_DR	Cross Street: MCCHESENEY_DR	Location:	NW
ADA ID: 7CC27AD23952	Ramp Type: Perp	Initial Pass/Fail: Fail	Overall Compliance: No	Severity Score: 21.25

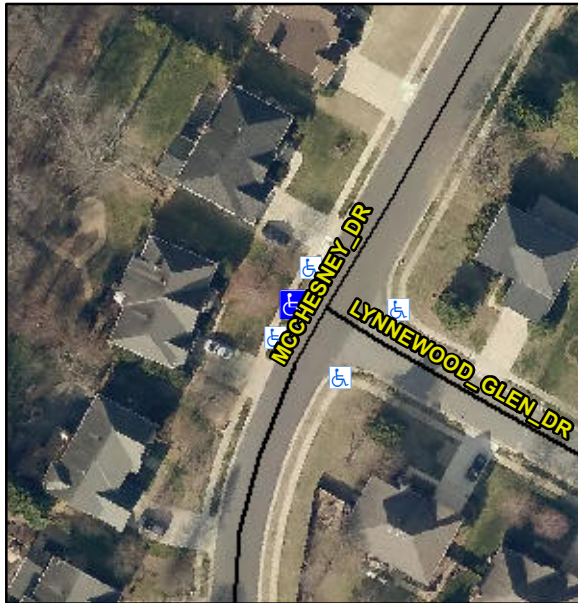
**Not Found, R304.5.1, R304.2.2**

Compliance	Description	Data	Compliance	Description	Data
N/A	Ramp Length (in)	47.0	No	Ramp Slope (%)	9.6
No	Ramp Width (in)	45.0	Yes	Ramp XSlope (%)	0.4
N/A	Flare Type LT	N/A	N/A	Flare Type RT	N/A
N/A	Flare Slope LT (%)	N/A	N/A	Flare Slope RT (%)	N/A
N/A	Flare Traversable LT?	N/A	N/A	Flare Traversable RT?	N/A
N/A	Landing Length (in)	N/A	N/A	DWS Provided?	N/A
N/A	Landing Width (in)	N/A	N/A	DWS Contrast?	N/A
N/A	Landing Slope (%)	N/A	N/A	DWS Length (in)	N/A
N/A	Landing X Slope (%)	N/A	N/A	DWS Full Width?	N/A
N/A	Landing Curb? (Y/N)	N/A	N/A	DWS Offset (in)	N/A
N/A	Shared Landing?	N/A			
N/A	Gutter Ponding?	N/A	N/A	Gutter Slope (%)	N/A
N/A	Gutter Lip Ht (in)	2.0	N/A	Gutter X Slope (%)	N/A
N/A	Painted X Walk1?	No	N/A	Painted X Walk2?	N/A
	X Walk 1 Direction	To SE		X Walk 2 Direction	N/A
N/A	X Walk 1 Width (in)	N/A	N/A	X Walk 2 Width (in)	N/A
	X Walk 1 Slope (%)	2.1		X Walk 2 Slope (%)	N/A
	X Walk 1 X Slope (%)	0.7		X Walk 2 X Slope (%)	N/A

N/A	Ramp inside XWalk1?	N/A	N/A	Ramp inside XWalk2?	N/A
	Road Slope (%)	N/A	N/A	Clear Space?	N/A
	Road X Slope (%)	N/A	N/A	Clear Space to XWalk (in)	N/A
N/A	Any Obstructions?	N/A	N/A	Storm Grate/Utility Hazard?	N/A
	Obstruction Type			Storm Grate/Utility Type	
		N/A			N/A
			Yes	Surface Condition? (G/P)	Good

### Remove & Replace Entire Ramp.

**Total Cost: \$ 1850.00**
