Access Compliance Report

Public Rights-of-Way

(Curb Ramps)

Intersection ID: 14011	Main Street: WEST_BV	Cross Street: ROMARE_BEARDEN_DR	Location: SW
ADA ID: 7CCAAAC9328A	Ramp Type: PerpDiag	Initial Pass/Fail: Fail	Overall Compliance: No
			Severity Score: 10

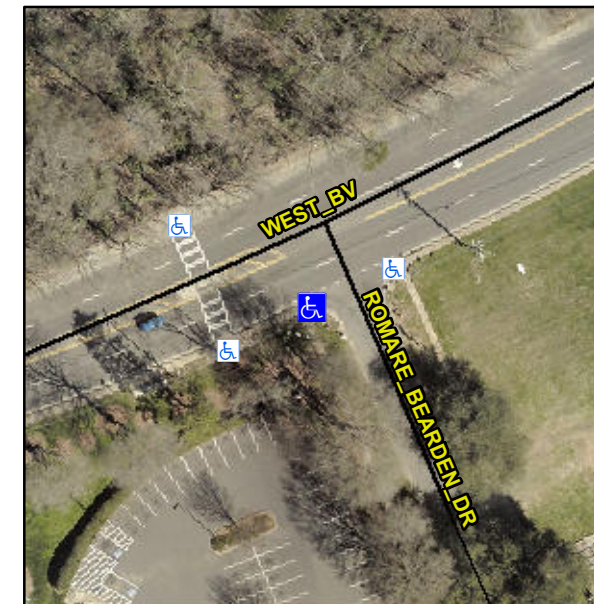
Not Found, R304.5.1, R304.5.3

Compliance	Description	Data	Compliance	Description	Data
N/A	Ramp Length (in)	51.0	Yes	Ramp Slope (%)	8.3
No	Ramp Width (in)	36.0	No	Ramp XSlope (%)	4.4
N/A	Flare Type LT	N/A	N/A	Flare Type RT	N/A
N/A	Flare Slope LT (%)	N/A	N/A	Flare Slope RT (%)	N/A
N/A	Flare Traversable LT?	N/A	N/A	Flare Traversable RT?	N/A
N/A	Landing Length (in)	N/A	N/A	DWS Provided?	N/A
N/A	Landing Width (in)	N/A	N/A	DWS Contrast?	N/A
N/A	Landing Slope (%)	N/A	N/A	DWS Length (in)	N/A
N/A	Landing X Slope (%)	N/A	N/A	DWS Full Width?	N/A
N/A	Landing Curb? (Y/N)	N/A	N/A	DWS Offset (in)	N/A
N/A	Shared Landing?	N/A			
N/A	Gutter Ponding?	N/A	N/A	Gutter Slope (%)	N/A
N/A	Gutter Lip Ht (in)	N/A	N/A	Gutter X Slope (%)	N/A
N/A	Painted X Walk1?	No	N/A	Painted X Walk2?	No
	X Walk 1 Direction	To E		X Walk 2 Direction	To N
N/A	X Walk 1 Width (in)	N/A	N/A	X Walk 2 Width (in)	N/A
	X Walk 1 Slope (%)	0.1		X Walk 2 Slope (%)	3.5
	X Walk 1 X Slope (%)	2.5		X Walk 2 X Slope (%)	1.9

N/A	Ramp inside XWalk1?	N/A	N/A	Ramp inside XWalk2?	N/A
	Road Slope (%)	3.8	N/A	Clear Space?	N/A
	Road X Slope (%)	1.6	N/A	Clear Space to XWalk (in)	N/A
N/A	Any Obstructions?	N/A	N/A	Storm Grate/Utility Hazard?	N/A
	Obstruction Type			Storm Grate/Utility Type	
		N/A			N/A
			Yes	Surface Condition? (G/P)	Good

Remove & Replace Curb Ramp With Two New Directional Ramps or Equivalent.

Total Cost: \$ 3200.00
