Access Compliance Report

Public Rights-of-Way (Curb Ramps)

Intersection ID: 3062	Main Street: LOGANVILLE_DR	Cross Street: BENFIELD_RD	Location:	N
ADA ID: 7CDA017DE7EA	Ramp Type: Directional1	Initial Pass/Fail: Fail	Overall Compliance: No	Severity Score: 12.5
Codes/Mitigation Info/Possible Solution		Field Measurements/Component Compliance

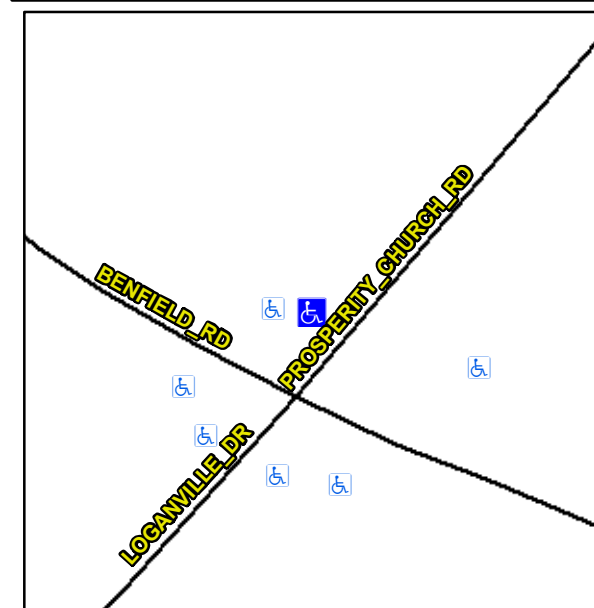
VEGETATION OVERGROWTH

R304.5.3

Compliance	Description	Data	Compliance	Description	Data
N/A	Ramp Length (in)	50.0	N/A	Grade Break?	N/A
Yes	Ramp Width (in)	71.0	N/A	Grade Break Slope (%)	0.0
Yes	Ramp Slope (%)	3.5	N/A	Grade Break XSlope (%)	0.0
No	Ramp XSlope (%)	5.5			
N/A	Flare Type LT	N/A	N/A	Flare Type RT	N/A
N/A	Flare Slope LT (%)	N/A	N/A	Flare Slope RT (%)	0.0
N/A	Flare Traversable LT?	N/A	N/A	Flare Traversable RT?	N/A
N/A	Landing Length (in)	0.0	N/A	DWS Provided?	N/A
N/A	Landing Width (in)	0.0	N/A	DWS Contrast?	N/A
N/A	Landing Slope (%)	0.0	N/A	DWS Length (in)	N/A
N/A	Landing X Slope (%)	0.0	N/A	DWS Full Width?	N/A
N/A	Landing Curb? (Y/N)	N/A	N/A	DWS Offset LT (in)	N/A
N/A	Shared Landing?	N/A	N/A	DWS Offset RT (in)	N/A
N/A	Gutter Ponding?	0.0	N/A	Gutter Slope (%)	N/A
N/A	Gutter Lip Ht (in)	0.0	N/A	Gutter X Slope (%)	N/A
N/A	Painted X Walk1?	Yes		Road Slope (%)	0.2
	X Walk 1 Direction	To E		Road X Slope (%)	2.1
	X Walk 1 Width (in)	119.0		Clear Space?	N/A

X Walk 1 Slope (%)	0.2	N/A	Clear Space to XWalk (in)	N/A
	X Walk 1 X Slope (%)	2.1	N/A	Storm Grate/Utility Hazard?	N/A
N/A	Ramp inside XWalk1?	Yes		Storm Grate/Utility Type	
N/A	Any Obstructions?	N/A			N/A
	Obstruction Type		Yes	Surface Condition? (G/P)	Good
			N/A	Curb Slope (%)	19.4

Remove & Replace Entire Ramp.
