# Access Compliance Report

## Public Rights-of-Way

### (Curb Ramps)

Intersection ID: 14461	Main Street: E_WORTHINGTON_AV	Cross Street: LYNDHURST_AV	Location: W
ADA ID: 7CFB4C986EE2	Ramp Type: Perp	Initial Pass/Fail: Fail	Overall Compliance: No
Severity Score: 42.5			
Codes/Mitigation Info/Possible Solution		Field Measurements/Component Compliance

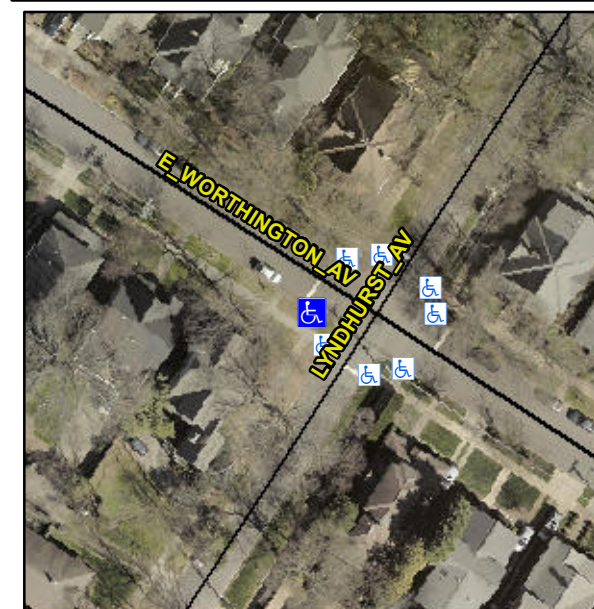
**Not Found, R304.5.1, R304.2.2, R304.5.3**

Compliance	Description	Data	Compliance	Description	Data
N/A	Ramp Length (in)	101.0	No	Ramp Slope (%)	10.8
No	Ramp Width (in)	32.0	No	Ramp XSlope (%)	6.1
N/A	Flare Type LT	N/A	N/A	Flare Type RT	N/A
N/A	Flare Slope LT (%)	N/A	N/A	Flare Slope RT (%)	N/A
N/A	Flare Traversable LT?	N/A	N/A	Flare Traversable RT?	N/A
N/A	Landing Length (in)	N/A	N/A	DWS Provided?	N/A
N/A	Landing Width (in)	N/A	N/A	DWS Contrast?	N/A
N/A	Landing Slope (%)	N/A	N/A	DWS Length (in)	N/A
N/A	Landing X Slope (%)	N/A	N/A	DWS Full Width?	N/A
N/A	Landing Curb? (Y/N)	N/A	N/A	DWS Offset (in)	N/A
N/A	Shared Landing?	N/A			
N/A	Gutter Ponding?	N/A	N/A	Gutter Slope (%)	N/A
N/A	Gutter Lip Ht (in)	N/A	N/A	Gutter X Slope (%)	N/A
N/A	Painted X Walk1?	No	N/A	Painted X Walk2?	N/A
	X Walk 1 Direction	To NE		X Walk 2 Direction	N/A
N/A	X Walk 1 Width (in)	N/A	N/A	X Walk 2 Width (in)	N/A
	X Walk 1 Slope (%)	6.4		X Walk 2 Slope (%)	N/A
	X Walk 1 X Slope (%)	1.2		X Walk 2 X Slope (%)	N/A

**Remove & Replace Entire Ramp.**

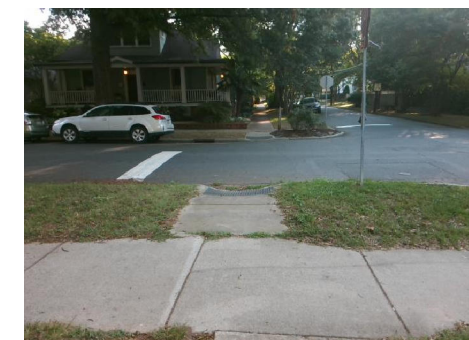
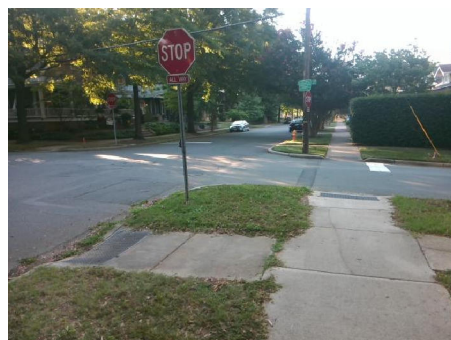
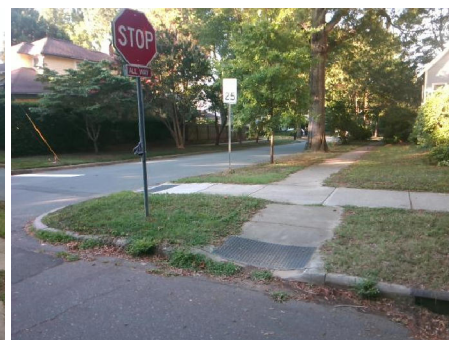
N/A	Ramp inside XWalk1?	N/A	N/A	Ramp inside XWalk2?	N/A
	Road Slope (%)	N/A	N/A	Clear Space?	N/A
	Road X Slope (%)	N/A	N/A	Clear Space to XWalk (in)	N/A
N/A	Any Obstructions?	N/A	N/A	Storm Grate/Utility Hazard?	N/A
	Obstruction Type			Storm Grate/Utility Type	
		N/A			N/A
			Yes	Surface Condition? (G/P)	Good
