Access Compliance Report Public Rights-of-Way (Curb Ramps)

Intersection ID: 12811	tersection ID: 12811 Main Street: SCHOOL_ST C					Cross Street: THOMAS_AV				
ADA ID: 7CFFCEAE5D4F				Initial Pass/Fail: Fail Overall Compliance: No				Location: O Severity Score:	SE 21.25	
Codes/Mitigation Info/Possible Solution				Field Measurements/Component Compliance						
Possible Solutions:				Compliance Description Data Compliance					Data	
		Remove & Replace Curb Ramp	Nith	N/A	Ramp Length (in)			Ramp Slope (%)	11.3	
		Two New Directional Ramps or	VILII	No	Ramp Width (in)		Yes	Ramp XSlope (%)	0.8	
		Equivalent.		N/A	Flare Type LT			Flare Type RT	N/A	
				N/A	Flare Slope LT (%)	N/A		Flare Slope RT (%)	N/A	
				N/A	Flare Traversable LT?		N/A	Flare Traversable RT?	N/A	
A second second second				N/A	Landing Length (in)		N/A	DWS Provided?	N/A	
Series		Surveyor Notes:		N/A	Landing Width (in)	N/A	N/A	DWS Contrast?	N/A	
		N/A		N/A	Landing Slope (%)	N/A		DWS Length (in)	N/A	
		174		N/A	Landing X Slope (%)	N/A	N/A	DWS Full Width?	N/A

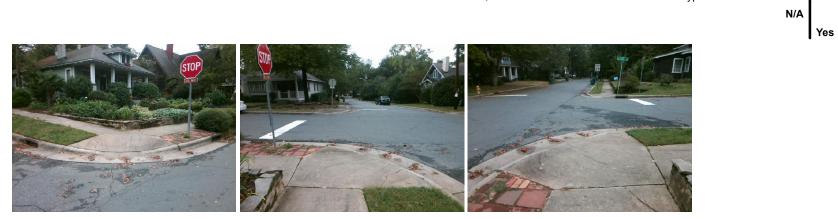
N/A	Landing Curb? (Y/N)	N/A	N/A	DWS Offset (in)	N/A	
	10			N/A	Shared Landing?	N/A		2		
		PROW/ADA:		N/A	Gutter Ponding?		N/A	Gutter Slope (%)	N/A	
				N/A	Gutter Lip Ht (in)	N/A	N/A	Gutter X Slope (%)	N/A

- Tearing		Not Found, R304.5.1, R304.2.2		N/A	Painted X Walk1?	No	N/A	Painted X Walk2?	No	
	Care and a second s			10/4	X Walk 1 Direction	To N	17/2	X Walk 2 Direction	To W	
	· · · · · · · · · · · · · · · · · · ·			N/A	X Walk 1 Width (in)	N/A	N/A	X Walk 2 Width (in)	N/A	
Street 1 Name	SCHOOL ST	1		11/1	X Walk 1 Slope (%)	4.2	17/2	X Walk 2 Slope (%)	1.9	
Stop Condition-Street 2	StopSign				X Walk 1 X Slope (%)	4.2 1.3		X Walk 2 X Slope (%)	0.8	
Stop Condition-Street 2	THOMAS AV			N/A	Ramp inside XWalk1?	-	N/A	Ramp inside XWalk2?	0.8 N/A	
				N/A	•	N/A 0.8	N/A	•	N/A N/A	
Stop Condition-Street 1	StopSign				Road Slope (%)			Clear Space?		
				NI/A	Road X Slope (%)	0.9	N/A	Clear Space to XWalk (in)	N/A	
		Tatal Ocat		N/A	Any Obstructions?	N/A	N/A	Storm Grate/Utility Hazard?	N/A	
		Total Cost: \$ 3	3200.00		Obstruction Type			Storm Grate/Utility Type		
						N/A			N/A

s Surface Condition? (G/P)

Good
