Access Compliance Report

Public Rights-of-Way

(Curb Ramps)

Intersection ID: N/A	Main Street: CRESSWIND BV	Cross Street: SHOFF CIR	Location: W
ADA ID: 7D156FA75DCE	Ramp Type: BlendTrans1	Initial Pass/Fail: Fail	Overall Compliance: No
Severity Score: 10			
Codes/Mitigation Info/Possible Solution		Field Measurements/Component Compliance

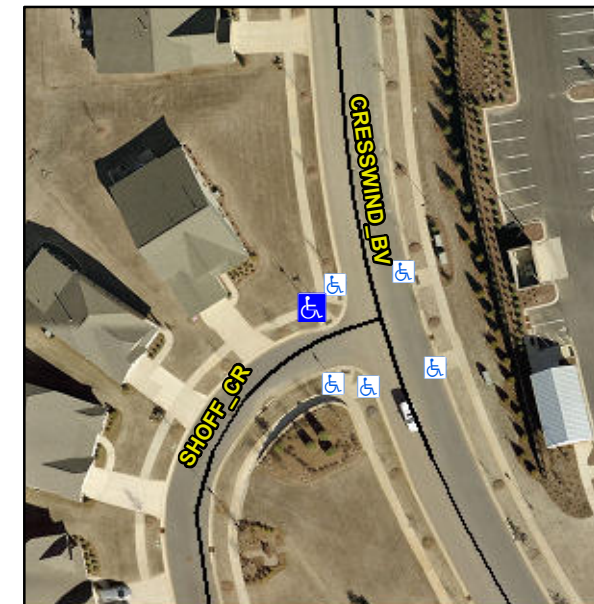
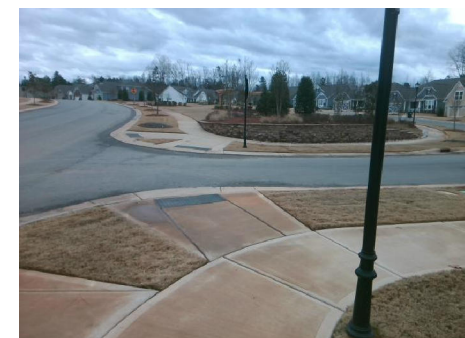
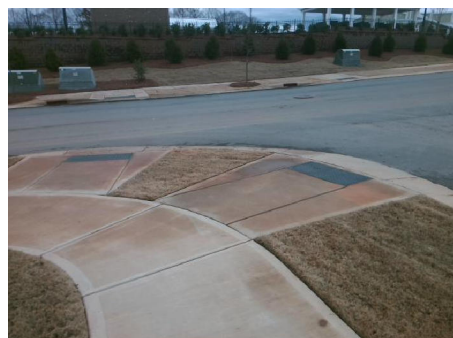
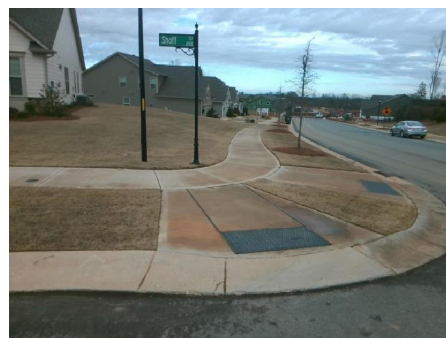
R304.5.1, R304.5.3

Compliance	Description	Data	Compliance	Description	Data
N/A	Ramp Length (in)	111.0	Yes	BlendTrans Slope (%)	0.6
No	Ramp Width (in)	47.0	No	BlendTrans XSlope (%)	4.0
N/A	Flare Type LT	N/A	N/A	Flare Type RT	N/A
N/A	Flare Slope LT (%)	N/A	N/A	Flare Slope RT (%)	N/A
N/A	Flare Traversable LT?	No	N/A	Flare Traversable RT?	No
N/A	Landing Length (in)	N/A	N/A	DWS Provided?	N/A
N/A	Landing Width (in)	N/A	N/A	DWS Contrast?	N/A
N/A	Landing Slope (%)	N/A	N/A	DWS Length (in)	N/A
N/A	Landing X Slope (%)	N/A	N/A	DWS Full Width?	N/A
N/A	Landing Curb? (Y/N)	N/A	N/A	DWS Offset (in)	N/A
N/A	Shared Landing?	N/A			
N/A	Gutter Ponding?	N/A	N/A	Gutter Slope (%)	N/A
N/A	Gutter Lip Ht (in)	0.5	N/A	Gutter X Slope (%)	N/A
N/A	Painted X Walk1?	No	N/A	Painted X Walk2?	N/A
	X Walk 1 Direction	To SE		X Walk 2 Direction	N/A
	X Walk 1 Width (in)	N/A		X Walk 2 Width (in)	N/A
	X Walk 1 Slope (%)	3.2		X Walk 2 Slope (%)	N/A
	X Walk 1 X Slope (%)	2.2		X Walk 2 X Slope (%)	N/A

N/A	Ramp inside XWalk1?	N/A	N/A	Ramp inside XWalk2?	N/A
	Road Slope (%)	2.2		Clear Space?	N/A
	Road X Slope (%)	3.2	N/A	Clear Space to XWalk (in)	N/A
N/A	Any Obstructions?	N/A	N/A	Storm Grate/Utility Hazard?	N/A
	Obstruction Type			Storm Grate/Utility Type	
		N/A			N/A
			Yes	Surface Condition? (G/P)	Good
			N/A	Curb Slope (%)	3.0

Remove & Replace Curb Ramp With Two New Directional Ramps or Equivalent.
