Access Compliance Report

Public Rights-of-Way

(Curb Ramps)

Intersection ID: 10030162	Main Street: LATHAM_PL	Cross Street: N/A	Location: N
ADA ID: 7D29D11D2B7B	Ramp Type: Perp	Initial Pass/Fail: Fail	Overall Compliance: No
Severity Score: 8.75			
Codes/Mitigation Info/Possible Solution		Field Measurements/Component Compliance

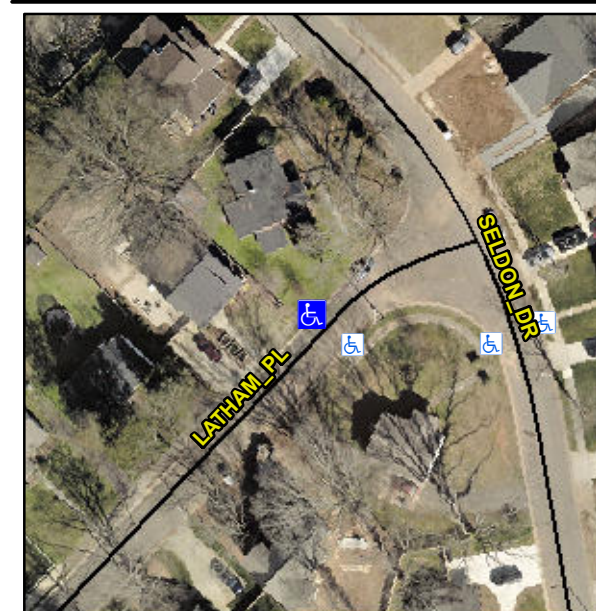
Compliance	Description	Data	Compliance	Description	Data
N/A	Ramp Length (in)	83.0	Yes	Ramp Slope (%)	5.0
No	Ramp Width (in)	47.0	Yes	Ramp XSlope (%)	1.7
N/A	Flare Type LT	N/A	N/A	Flare Type RT	N/A
N/A	Flare Slope LT (%)	N/A	N/A	Flare Slope RT (%)	N/A
N/A	Flare Traversable LT?	N/A	N/A	Flare Traversable RT?	N/A
N/A	Landing Length (in)	N/A	N/A	DWS Provided?	N/A
N/A	Landing Width (in)	N/A	N/A	DWS Contrast?	N/A
N/A	Landing Slope (%)	N/A	N/A	DWS Length (in)	N/A
N/A	Landing X Slope (%)	N/A	N/A	DWS Full Width?	N/A
N/A	Landing Curb? (Y/N)	N/A	N/A	DWS Offset (in)	N/A
N/A	Shared Landing?	N/A			
N/A	Gutter Ponding?	Yes	N/A	Gutter Slope (%)	N/A
N/A	Gutter Lip Ht (in)	0.8	N/A	Gutter X Slope (%)	N/A
N/A	Painted X Walk1?	No	N/A	Painted X Walk2?	N/A
	X Walk 1 Direction	To SE		X Walk 2 Direction	N/A
N/A	X Walk 1 Width (in)	N/A	N/A	X Walk 2 Width (in)	N/A
	X Walk 1 Slope (%)	4.3		X Walk 2 Slope (%)	N/A
	X Walk 1 X Slope (%)	0.1		X Walk 2 X Slope (%)	N/A

N/A	Ramp inside XWalk1?	N/A	N/A	Ramp inside XWalk2?	N/A
	Road Slope (%)	N/A	N/A	Clear Space?	N/A
	Road X Slope (%)	N/A	N/A	Clear Space to XWalk (in)	N/A
N/A	Any Obstructions?	N/A	N/A	Storm Grate/Utility Hazard?	N/A
	Obstruction Type			Storm Grate/Utility Type	
		N/A			N/A
			Yes	Surface Condition? (G/P)	Good

Possible Solutions:

Remove & Replace Entire Ramp.

Not Found, R304.5.1
