Access Compliance Report

Public Rights-of-Way

(Curb Ramps)

Intersection ID: N/A	Main Street: SUTHER_RD	Cross Street: SANDBURG_AV	Location: E
ADA ID: 7D2B16D8BB1C	Ramp Type: Directional1	Initial Pass/Fail: Fail	Overall Compliance: No
		Severity Score: 12.5

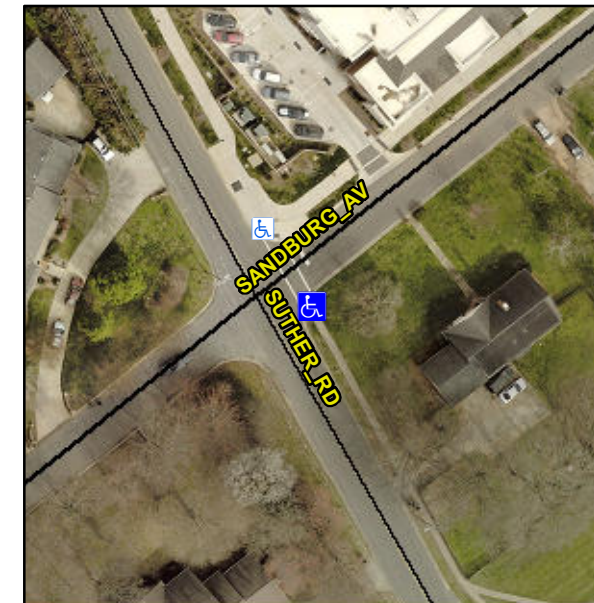
Compliance	Description	Data	Compliance	Description	Data
N/A	Ramp Length (in)	49.0	N/A	Grade Break?	N/A
Yes	Ramp Width (in)	48.0	N/A	Grade Break Slope (%)	0.0
Yes	Ramp Slope (%)	1.7	N/A	Grade Break XSlope (%)	0.0
No	Ramp XSlope (%)	5.8			
N/A	Flare Type LT	N/A	N/A	Flare Type RT	N/A
N/A	Flare Slope LT (%)	N/A	N/A	Flare Slope RT (%)	0.0
N/A	Flare Traversable LT?	N/A	N/A	Flare Traversable RT?	N/A
N/A	Landing Length (in)	0.0	N/A	DWS Provided?	N/A
N/A	Landing Width (in)	0.0	N/A	DWS Contrast?	N/A
N/A	Landing Slope (%)	0.0	N/A	DWS Length (in)	N/A
N/A	Landing X Slope (%)	0.0	N/A	DWS Full Width?	N/A
N/A	Landing Curb? (Y/N)	N/A	N/A	DWS Offset LT (in)	N/A
N/A	Shared Landing?	N/A	N/A	DWS Offset RT (in)	N/A
N/A	Gutter Ponding?	0.0	N/A	Gutter Slope (%)	N/A
N/A	Gutter Lip Ht (in)	0.0	N/A	Gutter X Slope (%)	N/A
N/A	Painted X Walk1?	Yes		Road Slope (%)	2.5
	X Walk 1 Direction	To NW		Road X Slope (%)	1.5
	X Walk 1 Width (in)	87.0		Clear Space?	N/A

X Walk 1 Slope (%)	2.5	N/A	Clear Space to XWalk (in)	N/A
	X Walk 1 X Slope (%)	1.5	N/A	Storm Grate/Utility Hazard?	N/A
N/A	Ramp inside XWalk1?	Yes		Storm Grate/Utility Type	
N/A	Any Obstructions?	N/A			N/A
	Obstruction Type		Yes	Surface Condition? (G/P)	Good
			N/A	Curb Slope (%)	16.9

Possible Solutions:

Remove & Replace Entire Ramp.
