# Access Compliance Report

## Public Rights-of-Way

### (Curb Ramps)

Intersection ID: 53270	Main Street: MONROE_RD	Cross Street: MERIDIAN_CENTER_DR	Location: NE
ADA ID: 7D2F41BC72C6	Ramp Type: Directional1	Initial Pass/Fail: Fail	Overall Compliance: No
Severity Score: 12.5			
Codes/Mitigation Info/Possible Solution		Field Measurements/Component Compliance

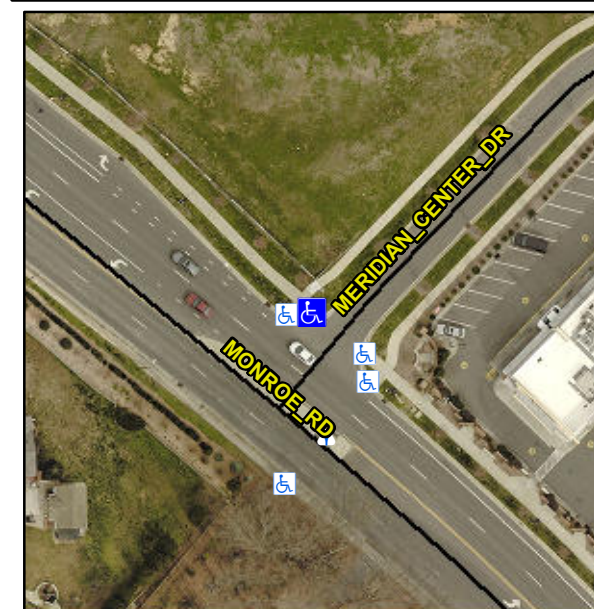
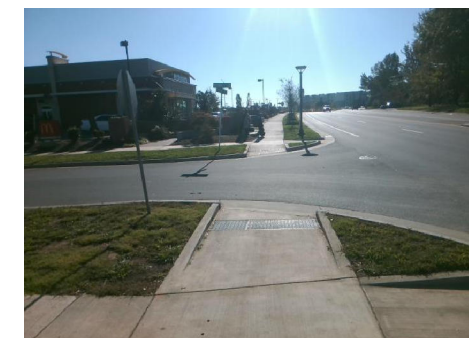
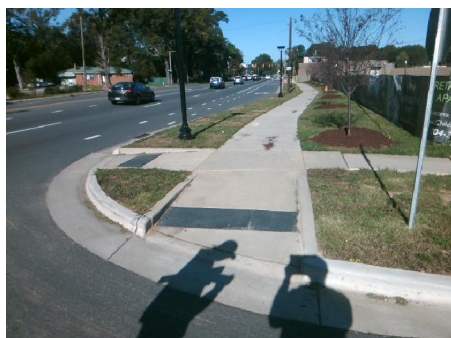
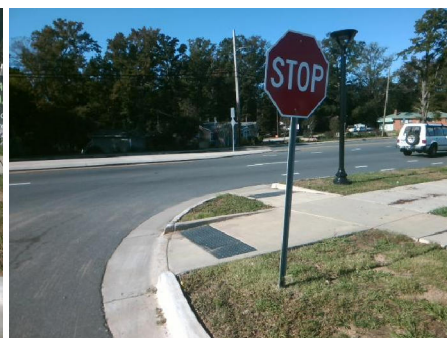
Compliance	Description	Data	Compliance	Description	Data
N/A	Ramp Length (in)	94.0	N/A	Grade Break?	N/A
Yes	Ramp Width (in)	72.0	N/A	Grade Break Slope (%)	0.0
No	Ramp Slope (%)	9.4	N/A	Grade Break XSlope (%)	0.0
Yes	Ramp XSlope (%)	0.1			
N/A	Flare Type LT	N/A	N/A	Flare Type RT	N/A
N/A	Flare Slope LT (%)	N/A	N/A	Flare Slope RT (%)	0.0
N/A	Flare Traversable LT?	N/A	N/A	Flare Traversable RT?	N/A
N/A	Landing Length (in)	0.0	N/A	DWS Provided?	N/A
N/A	Landing Width (in)	0.0	N/A	DWS Contrast?	N/A
N/A	Landing Slope (%)	0.0	N/A	DWS Length (in)	N/A
N/A	Landing X Slope (%)	0.0	N/A	DWS Full Width?	N/A
N/A	Landing Curb? (Y/N)	N/A	N/A	DWS Offset LT (in)	N/A
N/A	Shared Landing?	N/A	N/A	DWS Offset RT (in)	N/A
N/A	Gutter Ponding?	0.0	N/A	Gutter Slope (%)	N/A
N/A	Gutter Lip Ht (in)	0.0	N/A	Gutter X Slope (%)	N/A
N/A	Painted X Walk1?	No		Road Slope (%)	2.6
	X Walk 1 Direction	To E		Road X Slope (%)	0.5
	X Walk 1 Width (in)	N/A		Clear Space?	N/A

X Walk 1 Slope (%)	2.6	N/A	Clear Space to XWalk (in)	N/A
	X Walk 1 X Slope (%)	0.5	N/A	Storm Grate/Utility Hazard?	N/A
N/A	Ramp inside XWalk1?	N/A		Storm Grate/Utility Type	
N/A	Any Obstructions?	N/A			N/A
	Obstruction Type		Yes	Surface Condition? (G/P)	Good
			N/A	Curb Slope (%)	11.3

**Remove & Replace Entire Ramp.**

**R304.2.2**

\$ 1600.00
