Access Compliance Report Public Rights-of-Way (Curb Ramps)

| Intersection ID: 16547 | Main Street: E_W_T_HARRIS_BV | | Cross S | Cross Street: GREYWOOD_DR | | | | Location: | SW |
| ADA ID: 7D3647E77F9B | Ramp Type: PerpDiag | | Initial P | itial Pass/Fail: Fail Overall Compliance: N | | | ice: N | o Severity Score: | 12.5 |

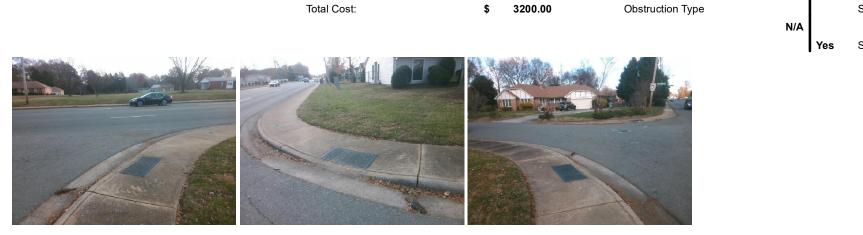
| Intersection ID: 16547 | Main Street: E_W_T_HARRIS_BV | | Cross S | Cross Street: GREYWOOD_DR | | | | Location: | SW |
|---|---|---|---|---|---|---|---|---|---|
| | | Remove & Replace Curb Ramp V | Vith | N/A | Ramp Length (in) | 60.0 | No | Ramp Slope (%) | 8.9 |
| | | Two New Directional Ramps or | - | Yes | Ramp Width (in) | 48.0 | Yes | Ramp XSlope (%) | 0.7 |
| | In the second | Not Found, R304.2.2 | | N/A | Gutter Lip Ht (in) | N/A | N/A | Gutter X Slope (%) | N/A |

| Intersection ID: 16547 | Main Street: E_W_T_HARRIS_BV | | Cross S | Cross Street: GREYWOOD_DR | | | | Location: | SW |
|---|---|---|---|---|---|---|---|---|---|
| | | Possible Solutions: | | Compliance Description | | | Data Compliance Description | | |
| | | Equivalent. | | N/A | Flare Type LT | N/A | N/A | Flare Type RT | N/A |
