# Access Compliance Report

## Public Rights-of-Way

| Intersection ID: 10661 | Main Street: N_DAVIDSON_ST | Cross Street: E_28TH_ST | Location: S |
| ADA ID: 7D364BF30FB9 | Ramp Type: BlendTrans1 | Initial Pass/Fail: Fail | Overall Compliance: No |

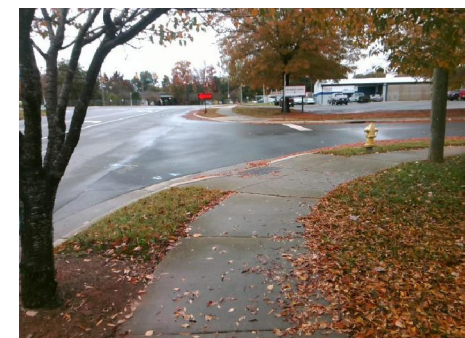
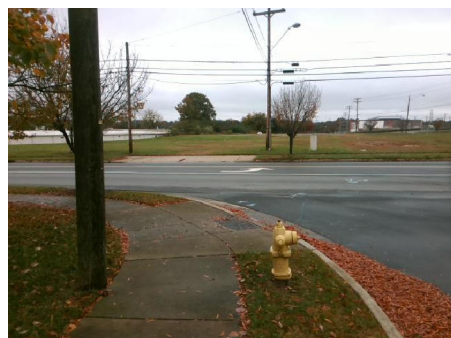
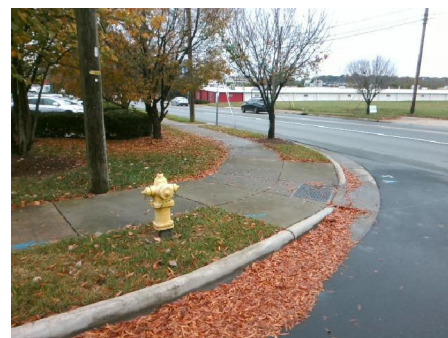
| Severity Score: 10 | | | |

**Not Found, R304.5.1, R304.5.3**

| Compliance | Description | Data | Compliance | Description | Data |
|---|---|---|---|---|---|
| No | Ramp Width (in) | 40.0 | No | BlendTrans XSlope (%) | 3.6 |
| | | | No | Curb Slope (%) | 15.7 |

**Remove & Replace Curb Ramp With Two New Directional Ramps or Equivalent.**

Total Cost: \$ 3200.00
