# Access Compliance Report

## Public Rights-of-Way

### (Curb Ramps)

Intersection ID: 18149	Main Street: BATHURST_DR	Cross Street: IDLEWILD_RD	Location: SW
ADA ID: 7D3DB5FB8D6D	Ramp Type: BlendTrans2	Initial Pass/Fail: Fail	Overall Compliance: No
Severity Score: 12.5			
Codes/Mitigation Info/Possible Solution		Field Measurements/Component Compliance

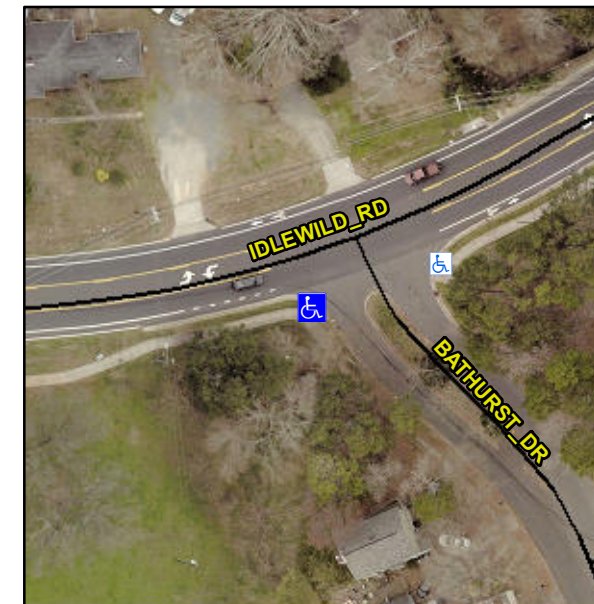
**CURB LIP 1.0**

**Not Found, R304.5.3**

Compliance	Description	Data	Compliance	Description	Data
N/A	Ramp Length (in)	131.0	Yes	BlendTrans Slope (%)	1.0
Yes	Ramp Width (in)	61.0	No	BlendTrans XSlope (%)	5.2
N/A	Flare Type LT	N/A	N/A	Flare Type RT	N/A
N/A	Flare Slope LT (%)	N/A	N/A	Flare Slope RT (%)	N/A
N/A	Flare Traversable LT?	N/A	N/A	Flare Traversable RT?	N/A
N/A	Landing Length (in)	N/A	N/A	DWS Provided?	N/A
N/A	Landing Width (in)	N/A	N/A	DWS Contrast?	N/A
N/A	Landing Slope (%)	N/A	N/A	DWS Length (in)	N/A
N/A	Landing X Slope (%)	N/A	N/A	DWS Full Width?	N/A
N/A	Landing Curb? (Y/N)	N/A	N/A	DWS Offset (in)	N/A
N/A	Shared Landing?	N/A			
N/A	Gutter Ponding?	N/A	N/A	Gutter Slope (%)	N/A
N/A	Gutter Lip Ht (in)	N/A	N/A	Gutter X Slope (%)	N/A
N/A	Painted X Walk1?	No	N/A	Painted X Walk2?	No
	X Walk 1 Direction	To NE		X Walk 2 Direction	To NW
	X Walk 1 Width (in)	N/A		X Walk 2 Width (in)	N/A
	X Walk 1 Slope (%)	5.5		X Walk 2 Slope (%)	5.7
	X Walk 1 X Slope (%)	6.1		X Walk 2 X Slope (%)	7.0

N/A	Ramp inside XWalk1?	N/A	N/A	Ramp inside XWalk2?	N/A
	Road Slope (%)	4.4		Clear Space?	N/A
	Road X Slope (%)	10.0	N/A	Clear Space to XWalk (in)	N/A
N/A	Any Obstructions?	N/A	N/A	Storm Grate/Utility Hazard?	N/A
	Obstruction Type			Storm Grate/Utility Type	
		N/A			N/A
			Yes	Surface Condition? (G/P)	Good
			No	Curb Slope (%)	12.0

**Remove & Replace Curb Ramp With Two New Directional Ramps or Equivalent.**
