# Access Compliance Report

## Public Rights-of-Way

### (Curb Ramps)

| Intersection ID: 9081 | Main Street: BEATTIES_FORD_RD | Cross Street: DUNDEEN_ST | Location: NW |

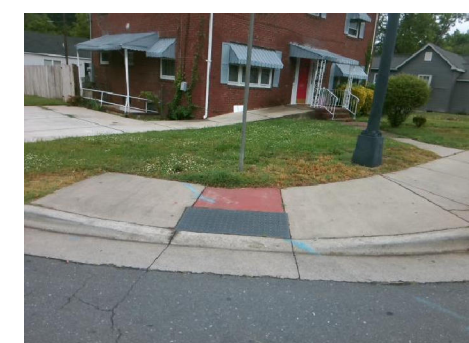
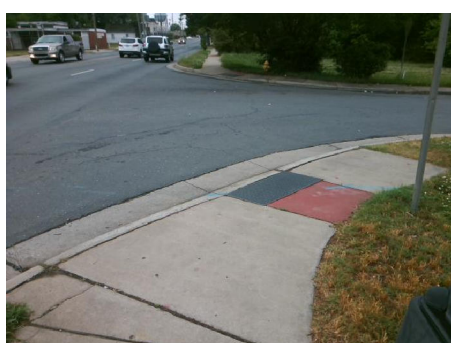
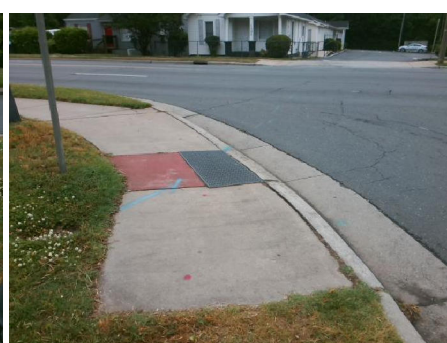
**Not Found, R304.5.1, R304.2.2, R304.5.3**

| Compliance | Description | Data | Compliance | Description | Data |
|---|---|---|---|---|---|
| N/A | Ramp Length (in) | 58.5 | No | Ramp Slope (%) | 8.4 |
| No | Ramp Width (in) | 41.0 | No | Ramp XSlope (%) | 3.6 |

**Remove & Replace Entire Ramp.**
