# Access Compliance Report

## Public Rights-of-Way

### (Curb Ramps)

Intersection ID: N/A	Main Street: EUCLID_AV	Cross Street: ATHERTON_ST	Location: W
ADA ID: 7D4BF5996E67	Ramp Type: PerpDiag	Initial Pass/Fail: Fail	Overall Compliance: No
Severity Score: 21.25			
Codes/Mitigation Info/Possible Solution		Field Measurements/Component Compliance

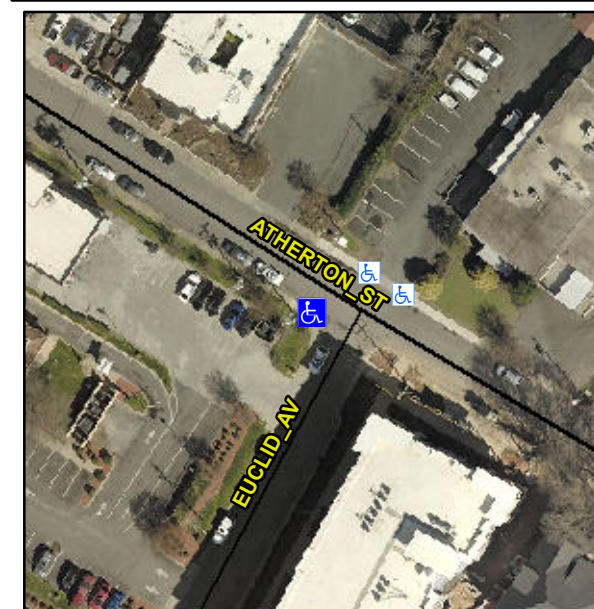
**Not Found, R304.5.1, R304.5.3**

Compliance	Description	Data	Compliance	Description	Data
N/A	Ramp Length (in)	51.0	Yes	Ramp Slope (%)	6.2
No	Ramp Width (in)	37.0	No	Ramp XSlope (%)	5.2
N/A	Flare Type LT	N/A	N/A	Flare Type RT	N/A
N/A	Flare Slope LT (%)	N/A	N/A	Flare Slope RT (%)	N/A
N/A	Flare Traversable LT?	N/A	N/A	Flare Traversable RT?	N/A
N/A	Landing Length (in)	N/A	N/A	DWS Provided?	N/A
N/A	Landing Width (in)	N/A	N/A	DWS Contrast?	N/A
N/A	Landing Slope (%)	N/A	N/A	DWS Length (in)	N/A
N/A	Landing X Slope (%)	N/A	N/A	DWS Full Width?	N/A
N/A	Landing Curb? (Y/N)	N/A	N/A	DWS Offset (in)	N/A
N/A	Shared Landing?	N/A			
N/A	Gutter Ponding?	N/A	N/A	Gutter Slope (%)	N/A
N/A	Gutter Lip Ht (in)	N/A	N/A	Gutter X Slope (%)	N/A
N/A	Painted X Walk1?	No	N/A	Painted X Walk2?	No
	X Walk 1 Direction	To SE		X Walk 2 Direction	To NE
N/A	X Walk 1 Width (in)	N/A	N/A	X Walk 2 Width (in)	N/A
	X Walk 1 Slope (%)	1.0		X Walk 2 Slope (%)	6.6
	X Walk 1 X Slope (%)	8.0		X Walk 2 X Slope (%)	2.9

N/A	Ramp inside XWalk1?	N/A	N/A	Ramp inside XWalk2?	N/A
	Road Slope (%)	5.8	N/A	Clear Space?	N/A
	Road X Slope (%)	7.7	N/A	Clear Space to XWalk (in)	N/A
N/A	Any Obstructions?	N/A	N/A	Storm Grate/Utility Hazard?	N/A
	Obstruction Type			Storm Grate/Utility Type	
		N/A			N/A
			Yes	Surface Condition? (G/P)	Good

**Remove & Replace Curb Ramp With Two New Directional Ramps or Equivalent.**

Total Cost: \$ 3200.00
