Access Compliance Report

Public Rights-of-Way

(Curb Ramps)

| Intersection ID: 30320 | Main Street: EUROSTAR_DR | Cross Street: STOURBRIDGE_LION_DR | Location: E |

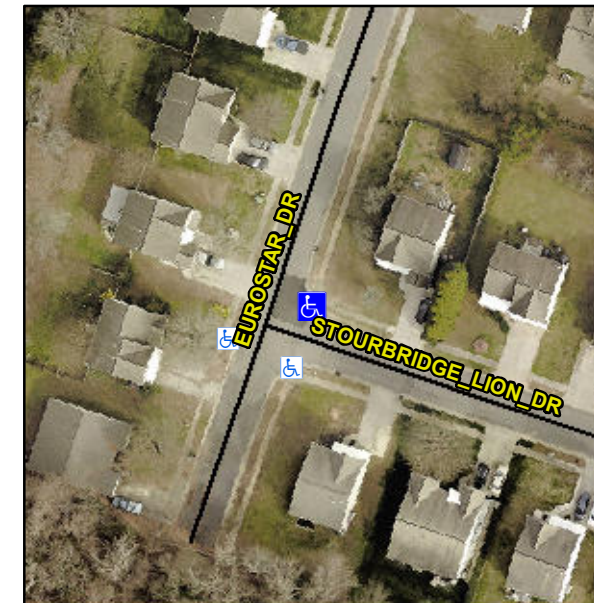
| ADA ID: 7D4D3372EC94 | Ramp Type: PerpDiag | Initial Pass/Fail: Fail | Overall Compliance: No |
| | | Severity Score: 22.5 | |

Not Found, R304.5.1, R304.2.2, R304.5.3

| Compliance | Description | Data | Compliance | Description | Data |
|---|---|---|---|---|---|
| N/A | Ramp Length (in) | 46.5 | No | Ramp Slope (%) | 9.0 |
| No | Ramp Width (in) | 47.0 | No | Ramp XSlope (%) | 5.0 |

Possible Solutions:

Remove & Replace Curb Ramp With Two New Directional Ramps or Equivalent.

Total Cost: \$ 3200.00
